**STS-100
FLIGHT READINESS REVIEW**

APRIL 5, 2001

ORBITER

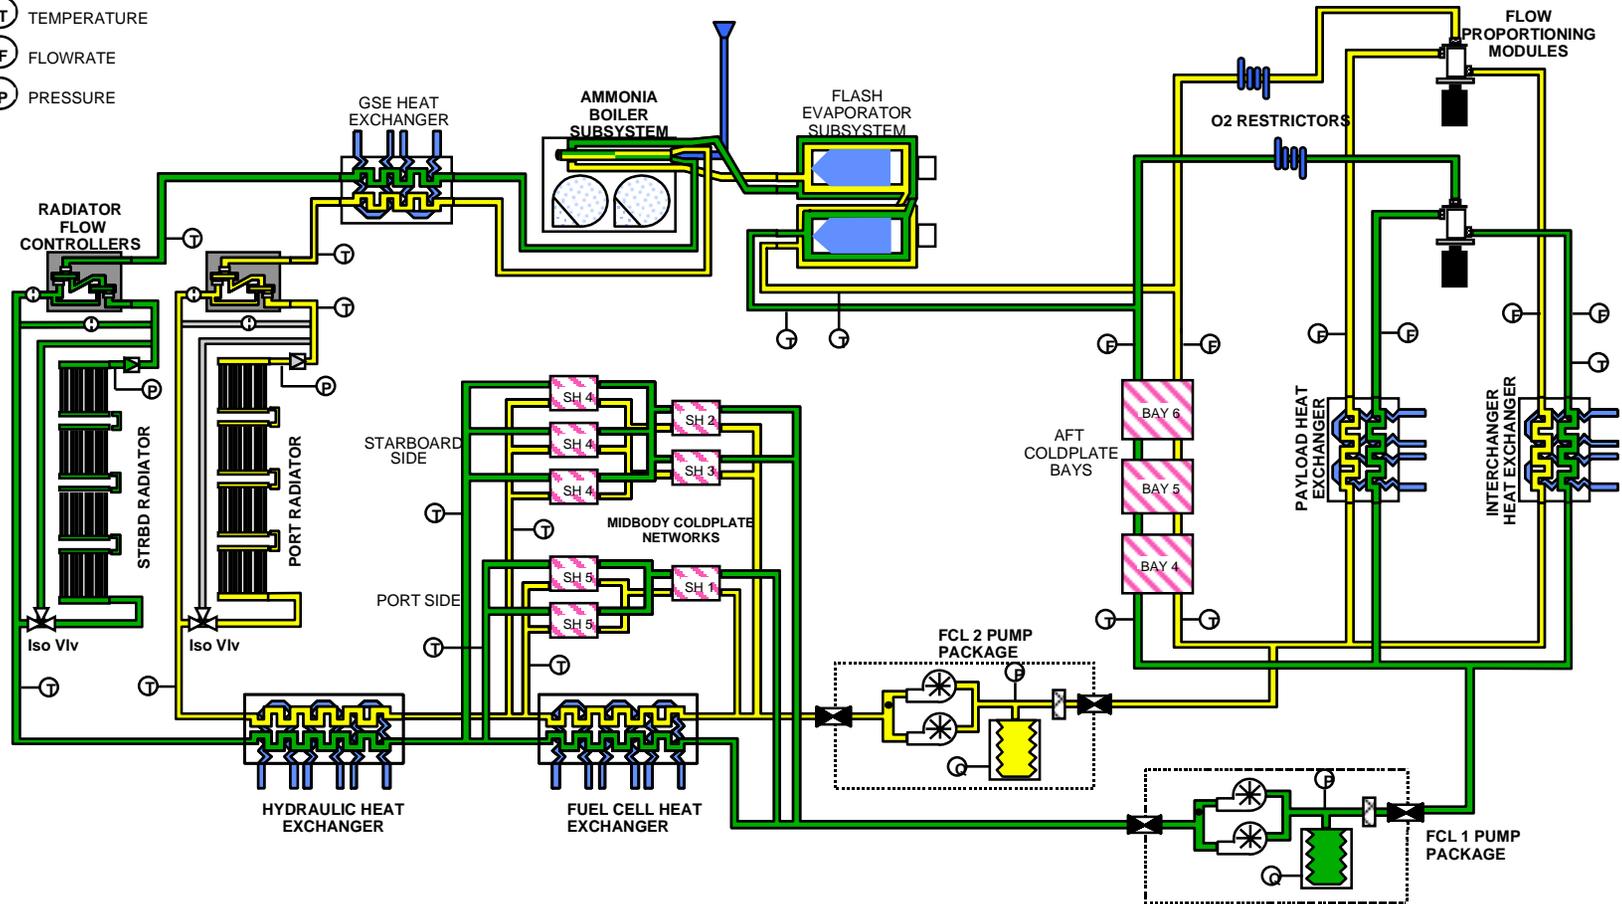
ORBITER ACTIVE THERMAL CONTROL SYSTEM (ATCS)

- During the STS-102 docked period, a FES water dump was performed
 - FES water dump requires RFCA to operate at high temperature setting which reduces radiator flow and panel temperature
 - A change to a colder reboost attitude, combined with the temperature effects of the FES water dump caused the radiator Freon temp to drop from -18°F to -75°F and flow decreased
 - Flow reduction was caused by water coming out of solution and turning into ice, creating blockage at the FCV filter
 - Radiator outlet temperature transducer was verified to be performing nominally
- After the flow reduction was observed, the FES dump was terminated by switching the RFCA to the “Normal” temperature setting

- Cause of flow reduction is attributed to the radiator being too cold, although current flight rule allows -85°F min Freon temperature
 - Radiator freon outlet temperature does not reflect a gradient across the radiator which is estimated to be ~50°F according to STS-35 data
 - Gradient is the result of variation in radiation environment temperature (caused by ISS shading and sun angle) seen by the radiator surface
 - Water can come out of solution in cold area and freeze
- Similar condition occurred during STS-28 where freon temperatures reached -77°F
- Review of STS-97 (OV-105 flt 15) showed that the same mission attitude as STS-102 was flown, however no freon loop freezing was observed
 - Outlet temperature was observed to reach -85°F

- Cause of flow reduction is understood and will be avoided in the future by mission planning
 - No hardware issues
 - Mission procedures will be updated to modify the radiator outlet temperature limit to prevent freeze-up
- Procedure to correct the problem in flight, should it occur, exists
 - Additional vehicle equipment power up and attitude change to warm up radiator
- OV-105 freon sample data has been verified to spec requirement
- OV-105 temperature sensor performance was verified to be nominal during STS-97 in-flight checkout

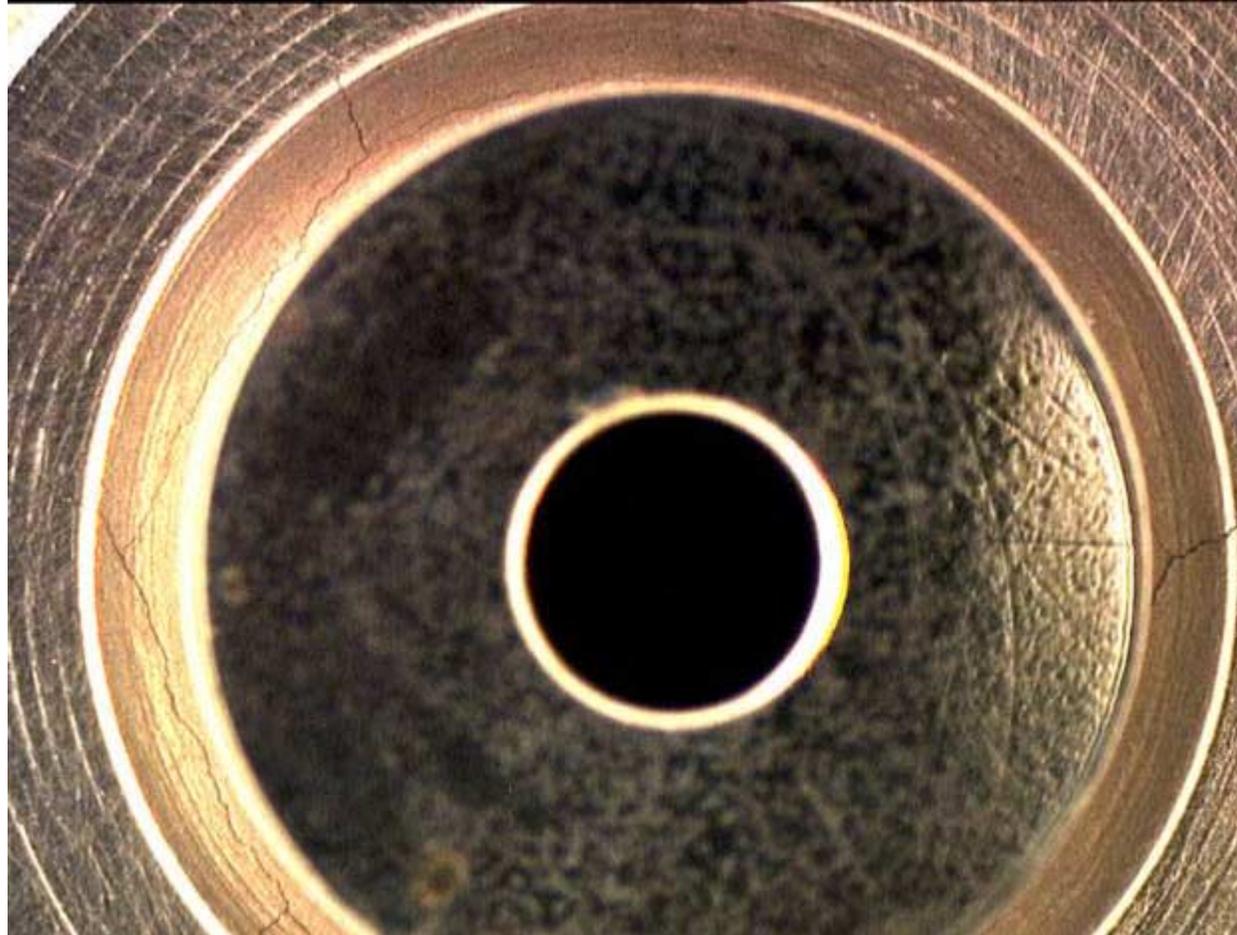
S/N 74 Cracked Seat Assembly

- Visible cracks found on the seat flange of S/N 74 H₂ T-0 valve opened at NSLD for TT&E of an internal leak

- The S/N 74 valve was removed from the panel and cut open for TT&E
- Cracks were visible on the flange of the seat
 - Testing confirmed leakage was through the seat cracks
- Cracks appear to originate at the outer weld and propagate inward toward the notch and then stay in the notch
- Cracks similar to those seen in earlier failed valves

- Cracking of valve seats attributed to hydrogen stress cracking
 - Failure analysis circa 1988 found 10 valves with same failure mechanism
 - H₂ stress cracking requires a susceptible material, hydrogen environment, and residual stress
 - Residual stresses can be from machining, welding, or assembly
 - Cracks will form and grow until residual stresses are relieved, stopping growth

- Failure analysis to be completed
- Need for long term corrective action to be determined

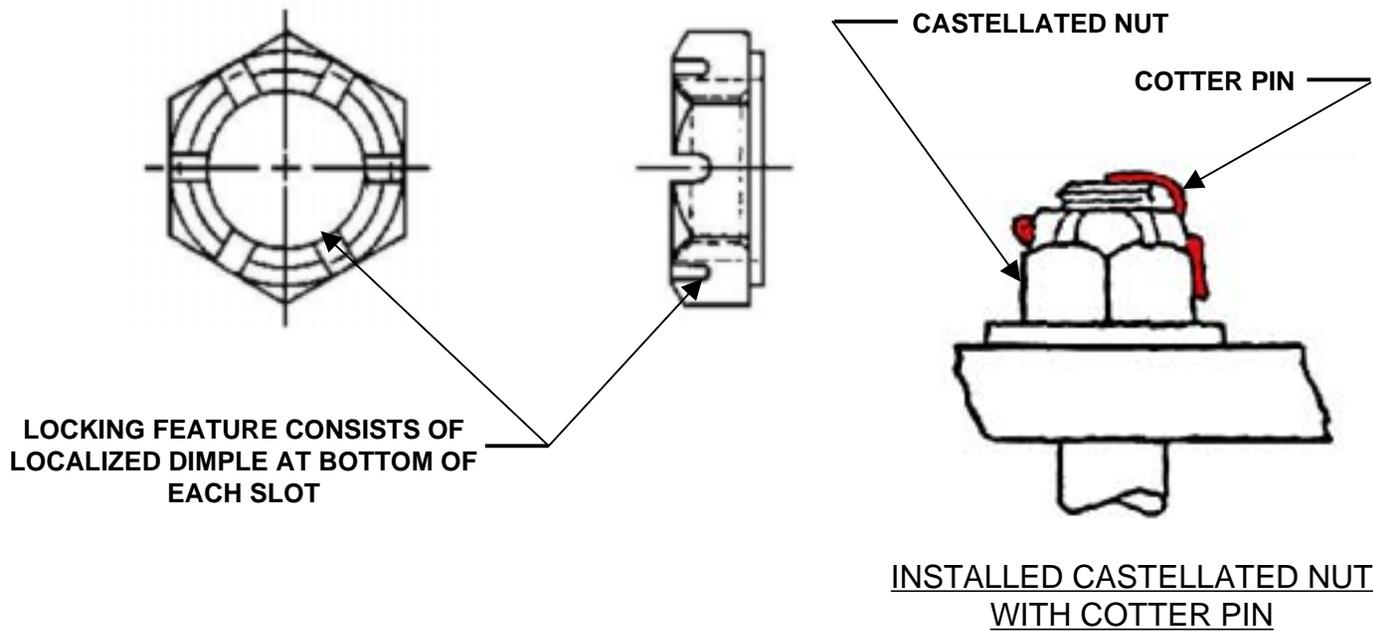
A286, THIN, SELF-LOCKING CASTELLATED NUT

- During installation of the castellated nuts on the remotely operated fluid umbilical (ROFU) mechanism at Palmdale, it was noted that the nuts could be installed (spun down) with little or no resistance
 - Examination of the nuts revealed that the locking feature had worn

- Castellated nut with cotter pin provides a positive locking device
- Requirements are in place to verify proper cotter pin installation by inspection during hardware assembly and as required by OMRS
- PRACA history indicates extremely low probability of a missing or broken cotter pin on any Orbiter installation
- Special inspections of OV-105 castellated nuts show proper cotter pin installation

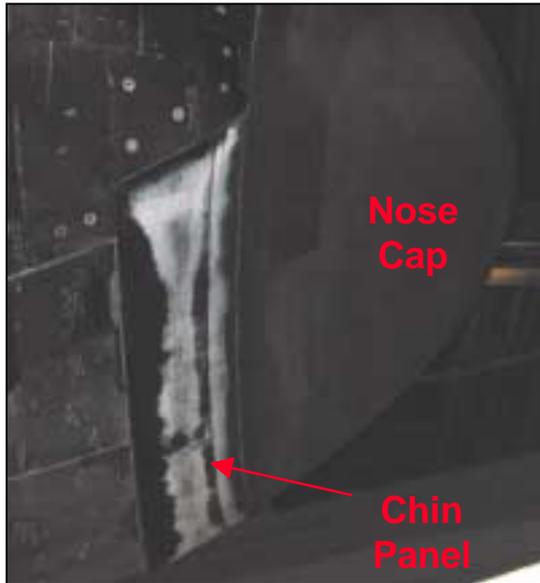
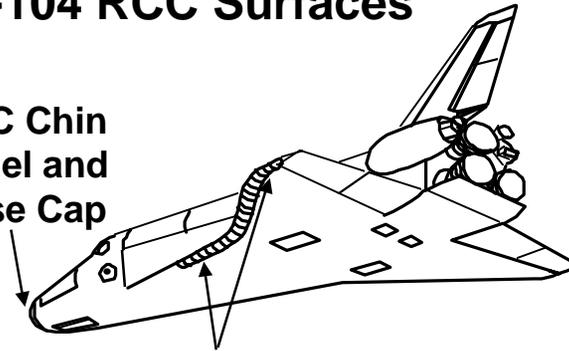
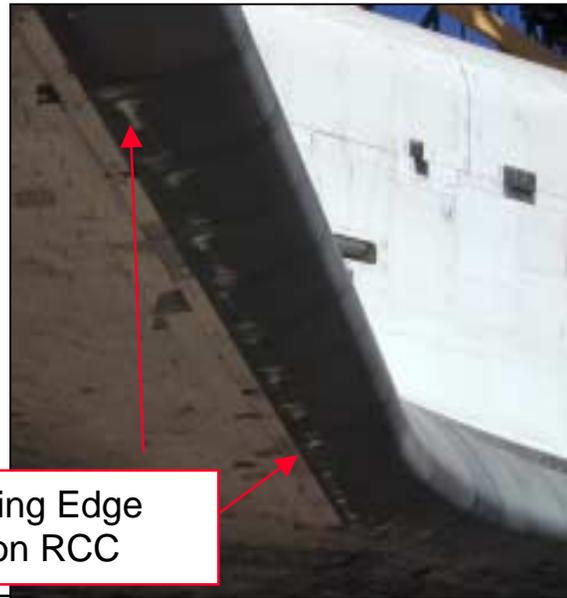
White Residue on OV-104 RCC Surfaces

- White residue was seen on OV-104's chin panel and some leading edge RCC panels prior to ferry flight from Dryden following STS-98
- Subsequently white residue was found on OV-102's nose cap and leading edge panels and OV-105's leading edge panels

- White residue was found and mapped on the external surfaces of OV-104, OV-102 and OV-105
 - Lab analysis of samples determined the material was sodium carbonate
 - Subsequently, residue was detected both visually and using pH checks
 - pH reading of 8-11 was used to indicate the presence of sodium carbonate in other locations
 - OV-104 had residue on 32 LE panels and the chin panel
 - Residue was found on this vehicle in the highest quantity
 - OV-105 had residue on 24 LE panels
 - OV-102 had residue on 23 LE panels and the nose cap
- On OV-104 residue was found on the internal surfaces of RCC Panel #14 and on the accompanying internal fittings and insulators but not on the LE spar
- The internal leading edge tiles at Panel #14 had several spots of contamination material
- No residue was found on any external TPS components

- Composition of the residue was analyzed and compared to possible environmental contaminants
 - Samples taken from the WLE hardware on all three vehicles were confirmed by analysis to be sodium carbonate with no other trace elements
 - One sample taken from the OV-104 chin panel was found by analysis to be sodium carbonate and boric acid
 - Presence of boric acid in this single sample is unexplained however not an adverse contaminant to RCC
 - Samples taken from Dryden contain sodium carbonate and boric acid but also silica and calcite
 - Based on the localization to the RCC only, the purity of the residue, the existence on unflown hardware, and the existence of elements within RCC to form sodium carbonate the most likely source is the RCC system itself

- Residue will not affect the short term performance of the RCC hardware
 - No safety of flight issue
- All external surfaces of the RCC panels on OV-105 with visual deposits have been cleaned
- 30x visual inspection after cleaning verified Type A sealant was intact and appeared normal
- Residue has not been found on external TPS and aluminum structure parts
- Residue is believed to be a product of the RCC components themselves and not an external contaminant
