**STS-109  
FLIGHT READINESS REVIEW**

**FEBRUARY 14, 2002**

**Orbiter**

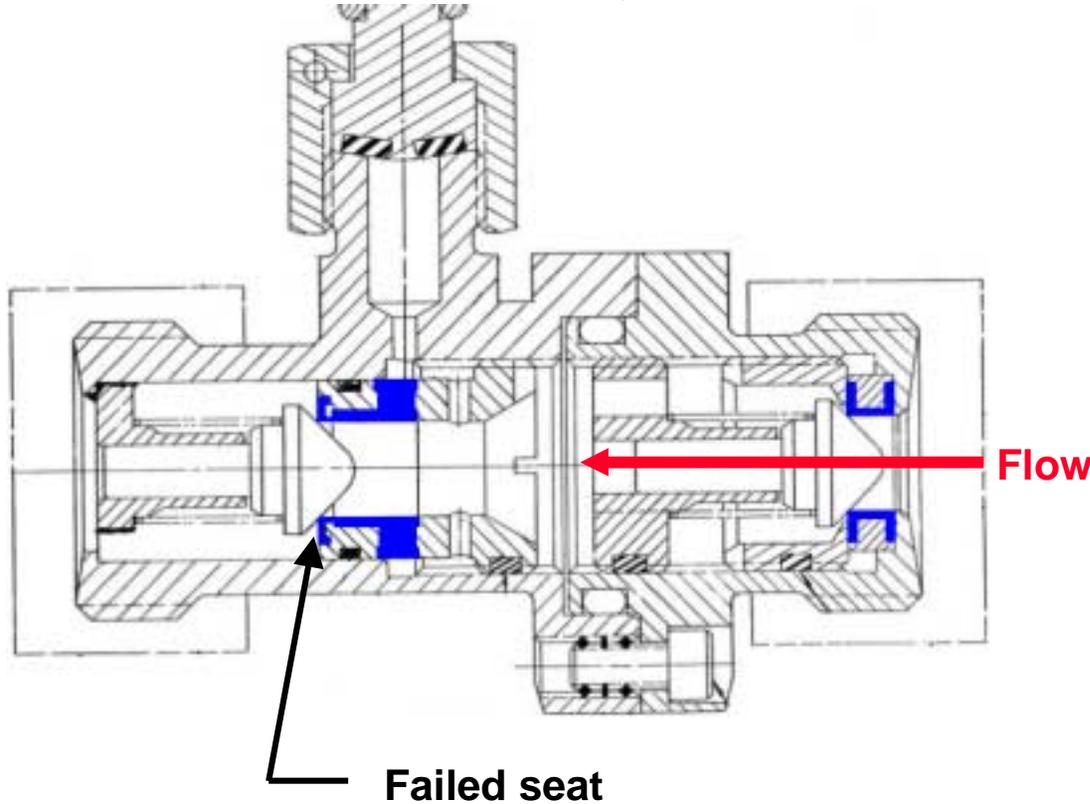
## Check Valve Assembly

- **Observation:**
  - During turn around processing, a WCS fan separator check valve (S/N 021) failed bubble leak check test
    - Flown on STS-98 and STS-105 in primary fan separator
    - Used for entire mission on both flights with no problems
- **Concern:**
  - Failure of both check valves could allow waste water to leak into the crew compartment
- **Discussion:**
  - Check valve was disassembled and inspected
  - Approximately 90% of the seat material was missing, and it is believed to never have been there
  - No evidence of residual material in areas where material is required
  - Material found was smooth; no appearance of cuts, tears, etc.

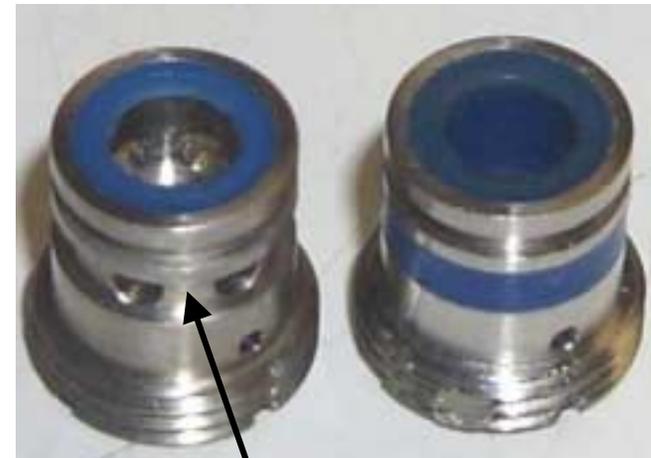
## Seat Assembly

Missing  
Seat  
Material

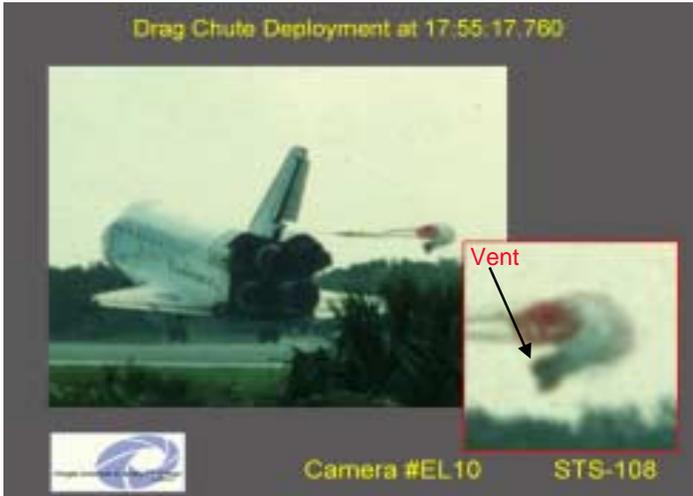
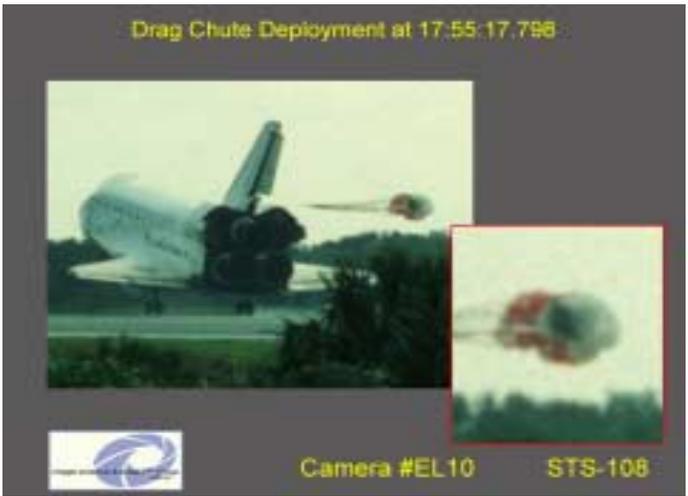
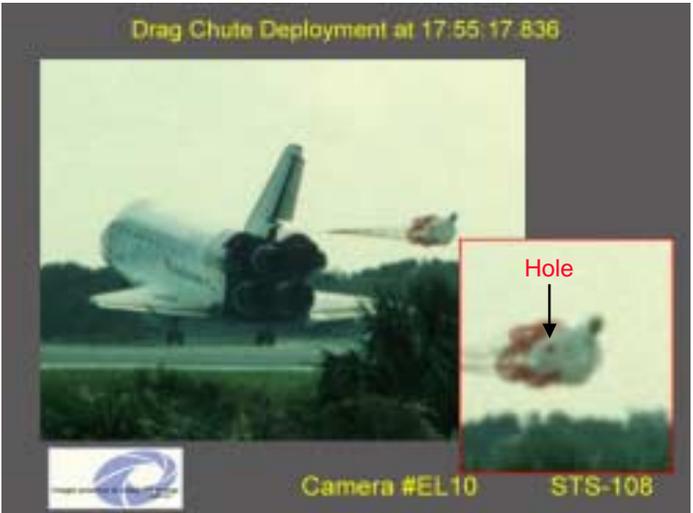
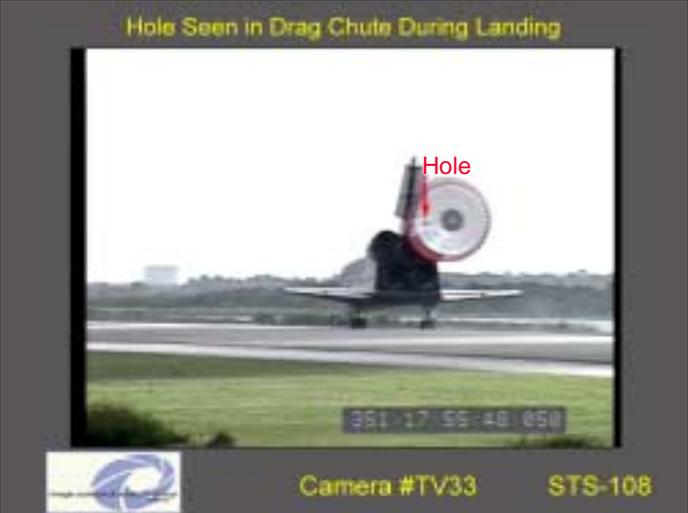
- STS-108 rollout videos show damage to the drag chute canopy
  - Hole appears shortly after deploy from bag
  - Parachute Refurbishment Facility (PRF) found ribbons 34 through 40 and one vertical tape on gore 31 damaged

- Damage/holes in drag chute canopy may produce uneven drag forces during rollout

- First ever incidence of damage to seven, 300-lb nylon ribbons in one location
  - Typical repair on a refurbished parachute shows one damaged ribbon at one or two locations
- Damaged vertical tape material is 90 lb strength double ply nylon tape

- Fault tree developed to identify all possible failure modes
- Most likely cause of damage is vent re-contact with canopy causing vent band/line(s) to damage ribbons

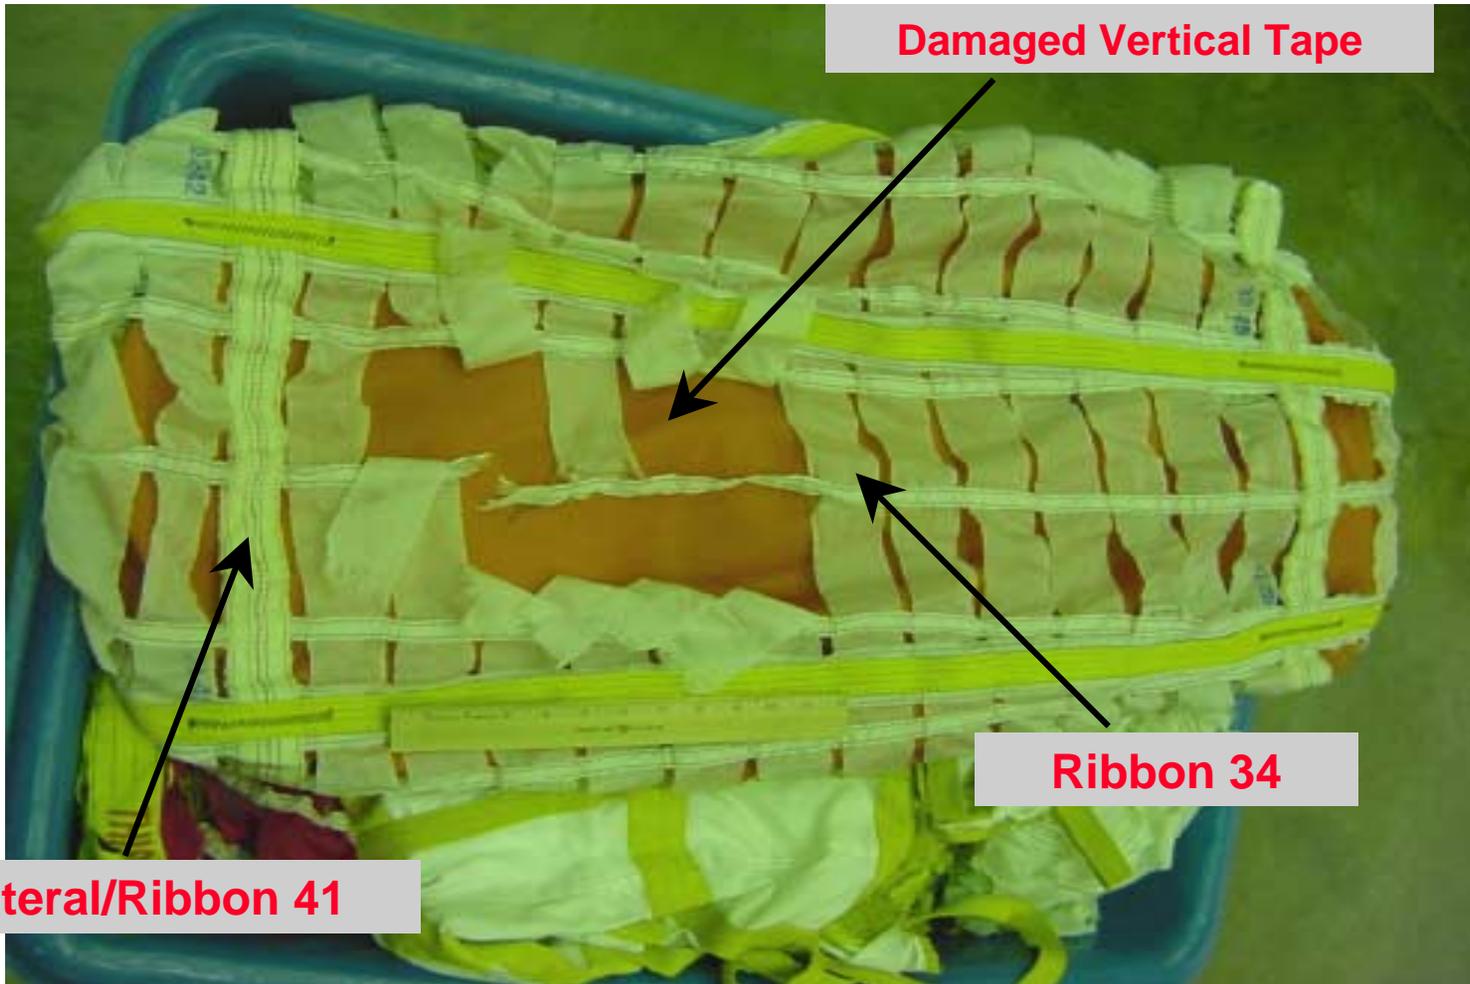
- 6 lateral bands, also known as “rip stops,” are designed to limit damage to localized areas
- Extensive review of landing rollout video performed by chute experts
  - Vent re-contacts canopy shortly after initial canopy deployment
    - Location of vent re-contact with canopy coincides with hole location
  - No signs of debris, loose objects, or bird strike
  - Drag chute door and sabot deployment show no signs of interfering with chute canopy
  - Past flight videos show dynamic motion of the STS-108 chute was equal to the most severe of 14 other flights reviewed
- NASA JSC M&P confirms majority of damage typical of strain/overload
  - Ribbons show minor friction burning
  - Indicates damage unlikely due to packing process

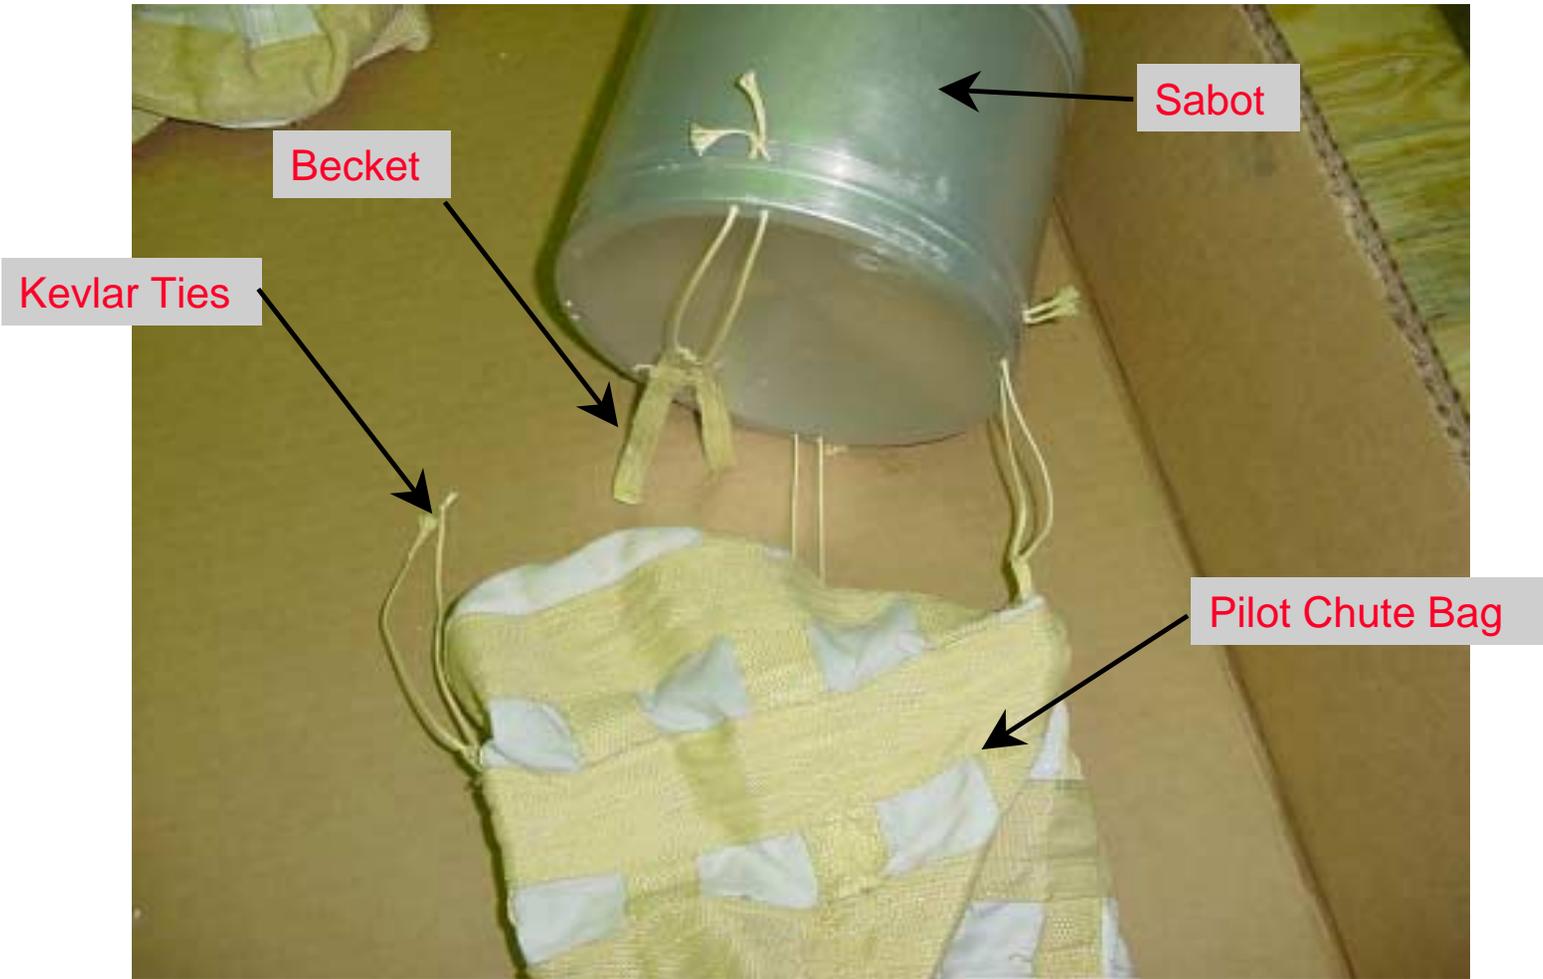
- A review of STS-108 drag parachute hardware at PRF identified one of four Kevlar ties that secure the pilot parachute deployment bag to the sabot was loose/untied
  - One of the three remaining deployment bag beackets/loops had completely torn loose from the bag while the two remaining loops have broken stitching
  - Kevlar ties on remaining three beackets/loop attachments to the sabot were intact
  - Remaining knots in loose tie showed evidence of loading prior to/during knot failure

- Loose ties holding sabot to deployment bag may result in improper pilot chute bag separation and subsequent failure of main chute to deploy

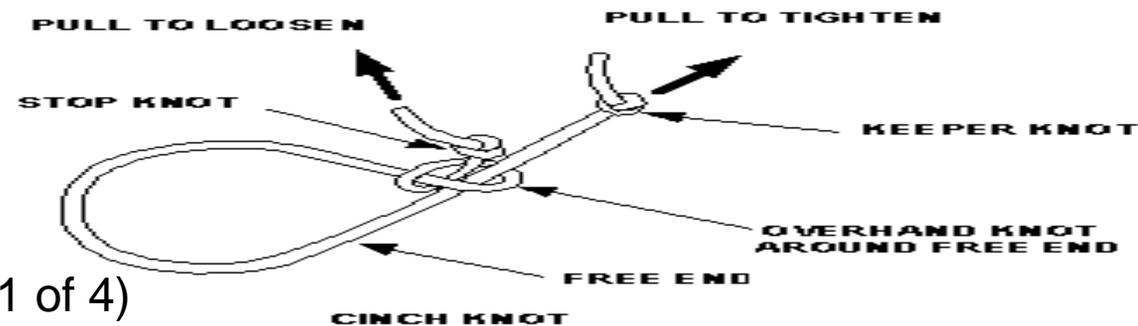
Kevlar Tie (1 of 4)

- Fault tree developed to identify all possible failure modes
- Most probable cause of the failed line is loss of or a missing stop knot and loosening of the cinch knot allowing the keeper knot to slip through the cinch knot
  - Inspection may have overlooked stop knot since all knots combine into single point
  - Opportunity exists for looseness in knots to occur during insertion or compression of sabot and bag into mortar tube
- First failure of tie likely caused subsequent failure of one bucket/loop on deployment bag

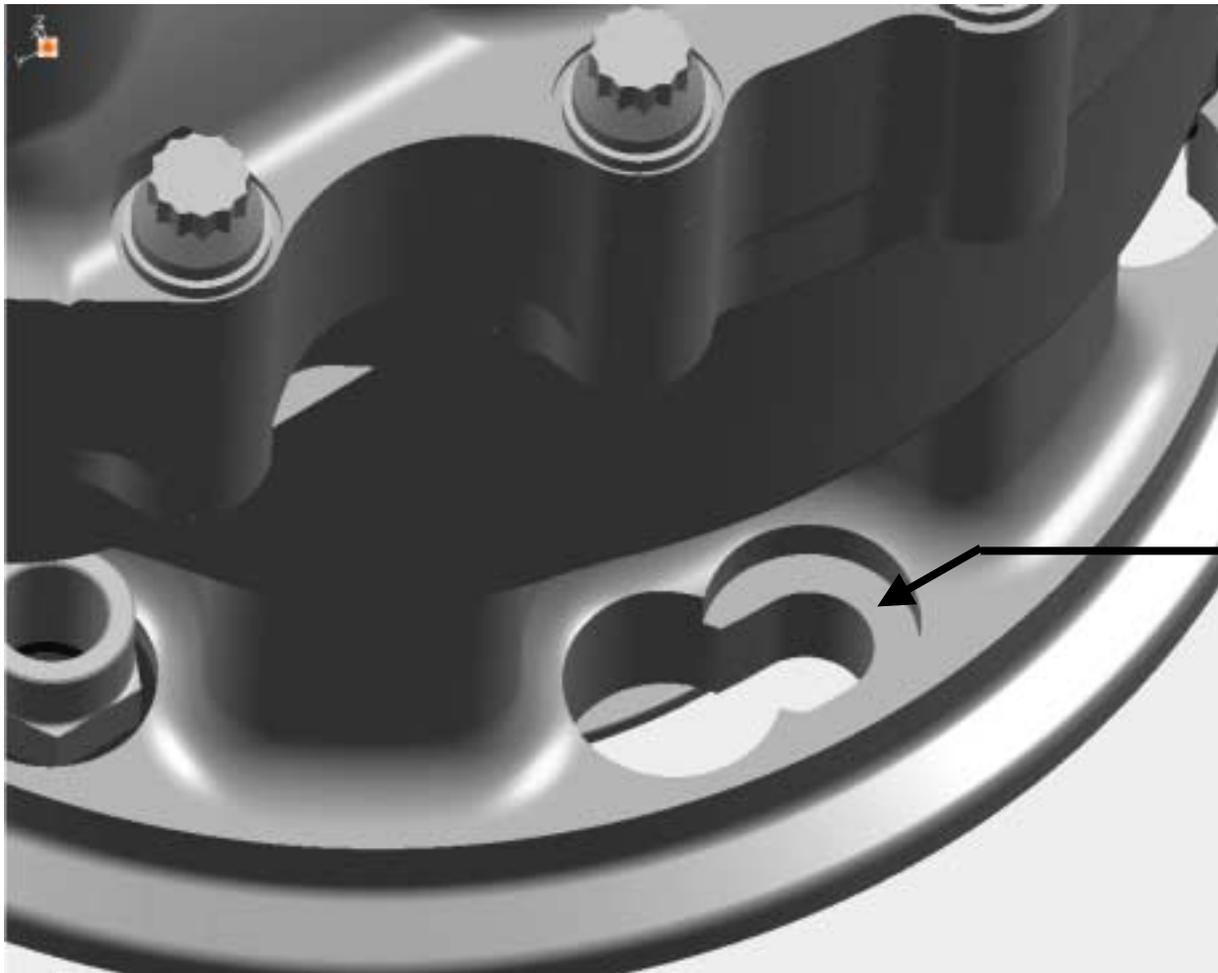
- A design change was made (April 2000) to increase the outside diameter of the washer from  $.640 \pm .010$  to  $.710 \pm .002$  to increase the load distribution area
  - Coining damage to pump mounting flanges had been observed from the smaller diameter washer
  - Larger washers have flown on OV-104 (3 flights) and OV-105 (1 flight)

Spot face  
coining  
occurred  
here

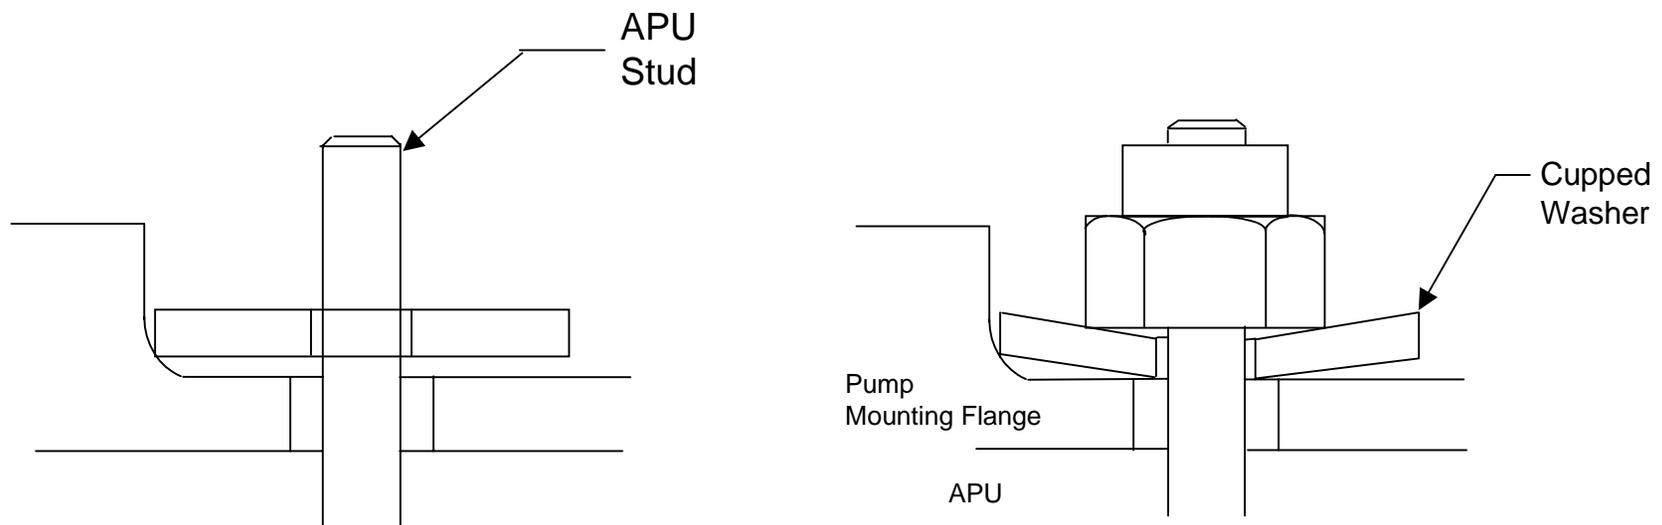
- Performed layout analysis of the installation
- Reviewed pump drawings and performed tolerance analysis
  - Determined that under worst case tolerance stack up, the larger diameter washers could interfere with the radius in the spot face
    - Application of torque causes the pump washer to bend
- Performed stress analysis of the installation

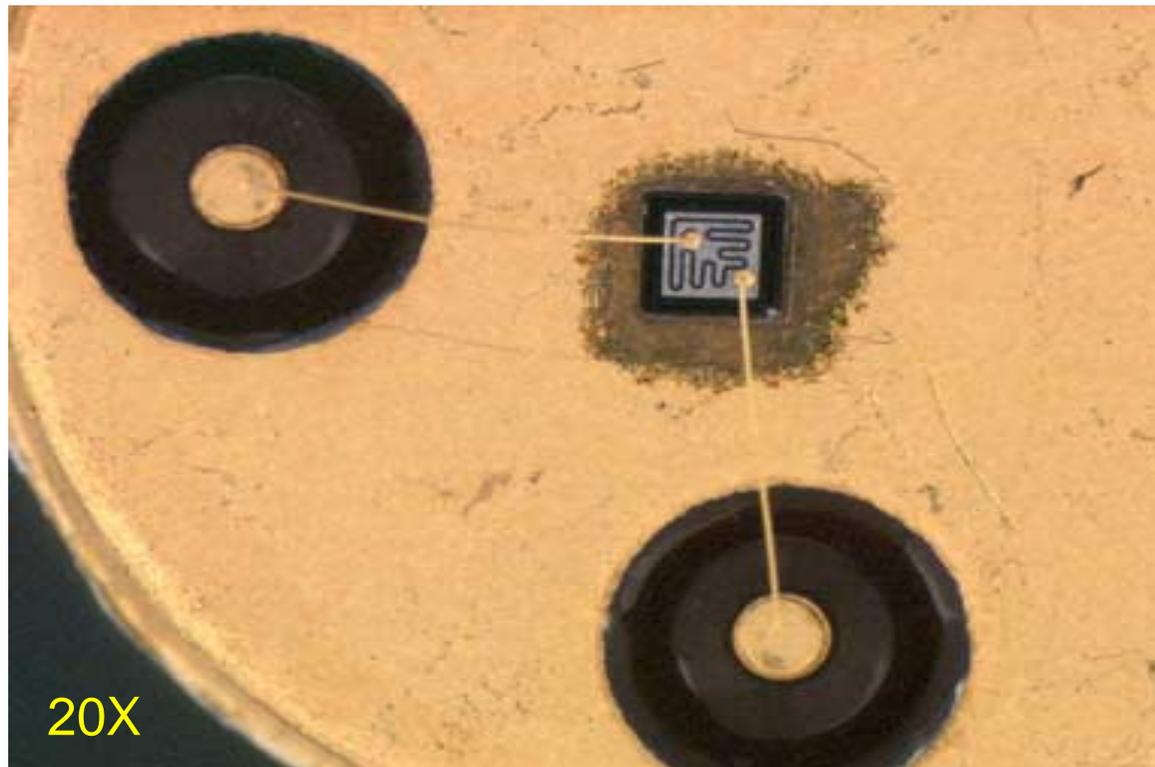
Figure 1

- The DSC CVRD module Q503 transistor failures (detached base and emitter bond wires) are illustrated in Figures 1 through 4

### Bond Wires Appear to be Attached to Die

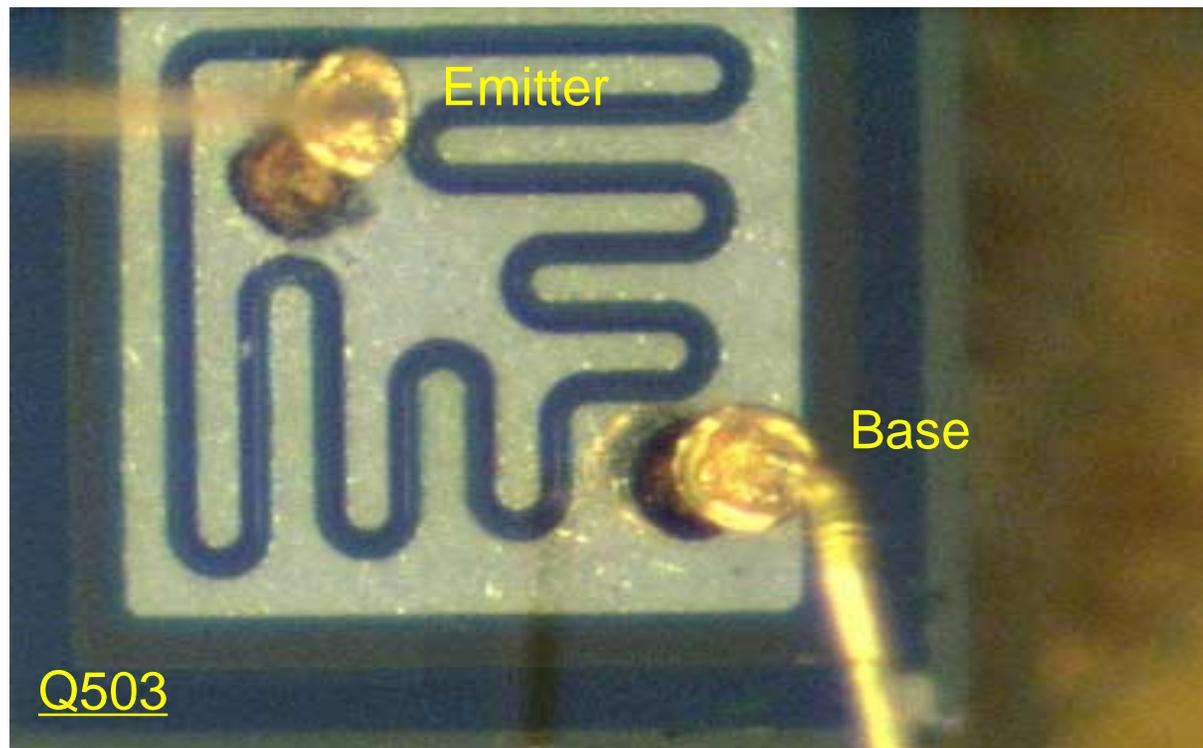
Figure 2

Closer Examination Shows Bond Wires Are Actually Detached

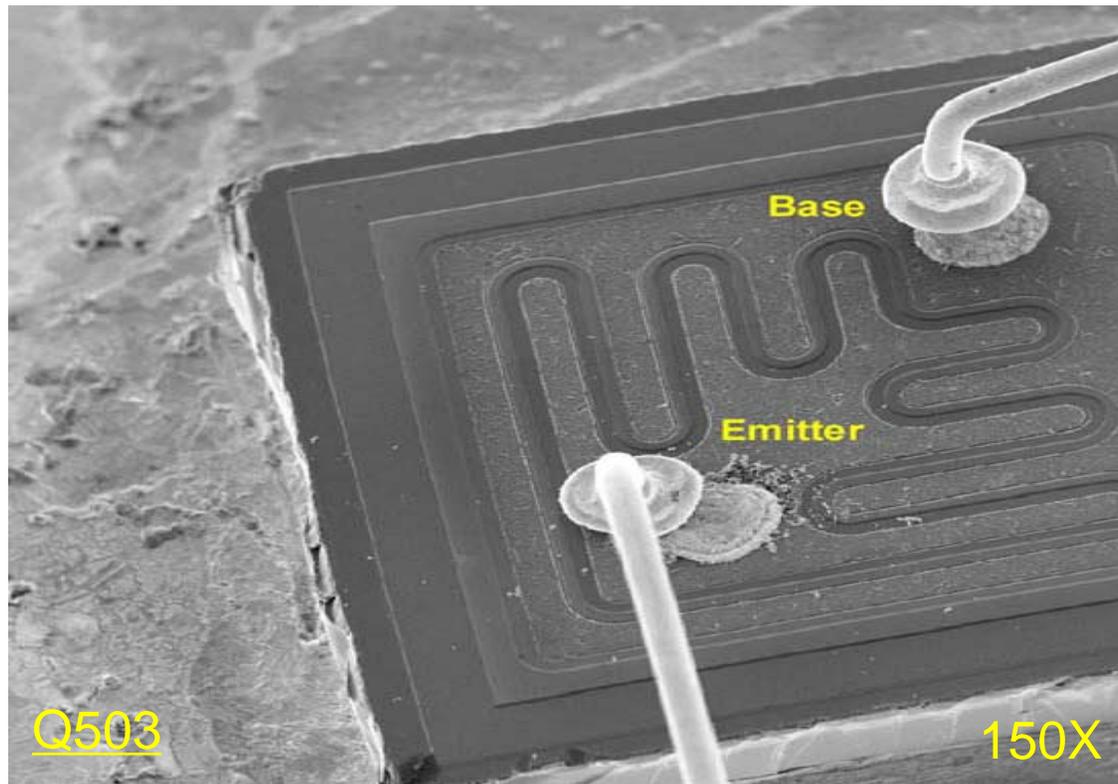
Figure 3

### SEM of Detached Base and Emitter Bond Wires

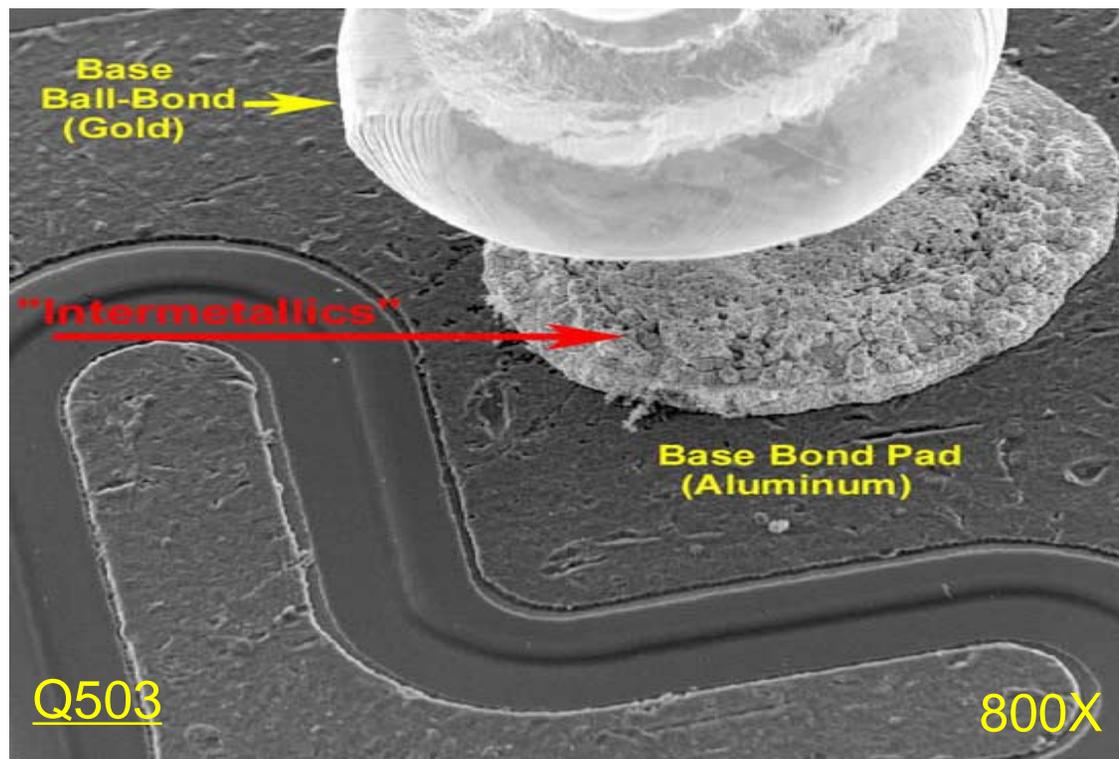
Figure 4

### SEM Showing Intermetallics In Bond Region

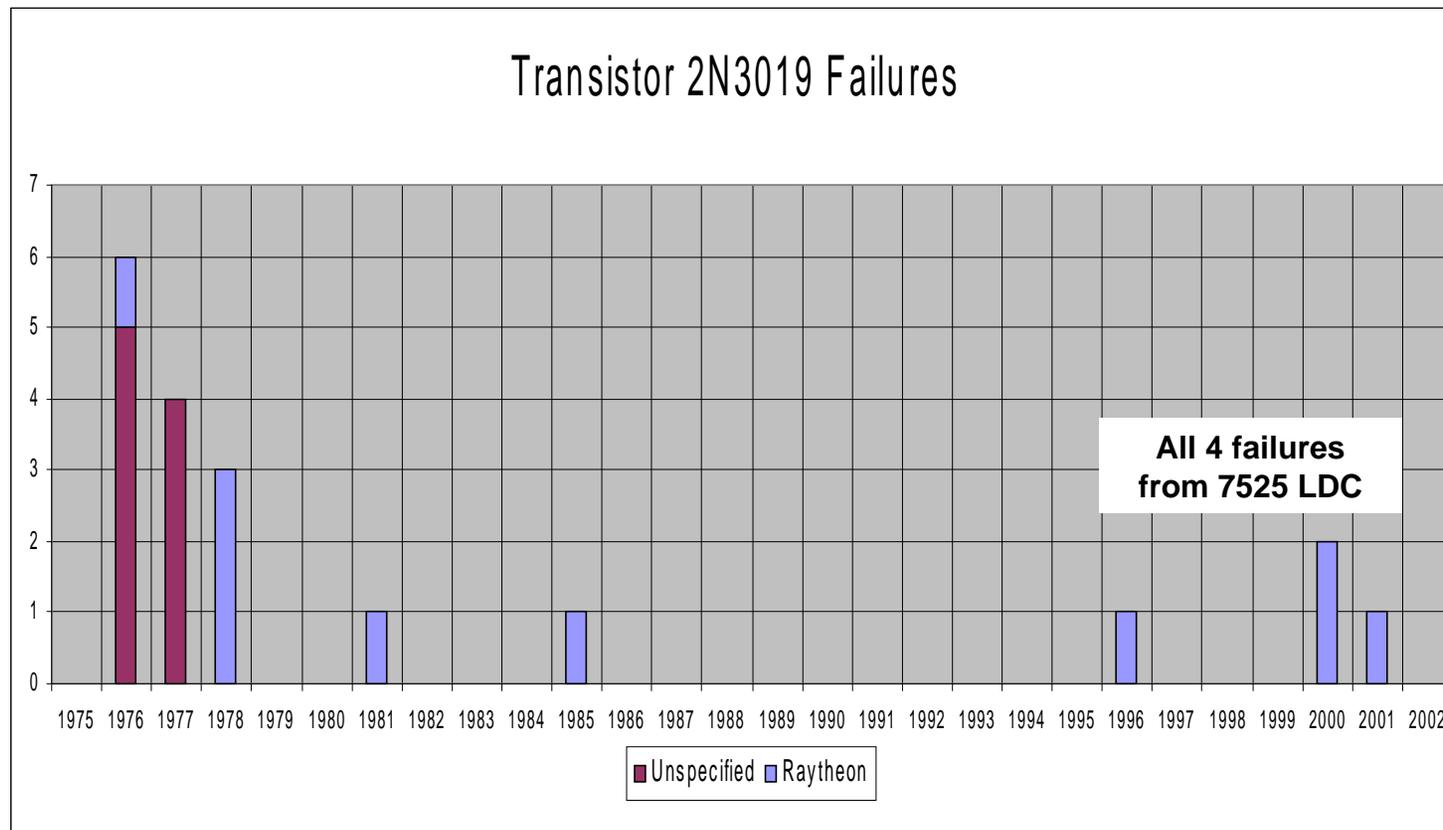
Figure 5

- Conducted PRACA history search to identify all 2N3019 transistor failures (refer to Figure 5)
  - Identified 16 CARs documenting 19 transistor failures (various manufacturers)
  - Due to incomplete documentation, only 8 CARs confirmed to involve Raytheon transistors
  - No records contained information regarding destructive failure analysis
    - One record indicated that transistor was de-lidded and photographed, but in most cases transistors were simply R&R'd
- Four recent failures led us to investigate LDC 7525 as a potential lot problem
  - Aerospace Corporation failure database
  - GIDEPs
  - Additional failure analysis at NSLD
  - Destructive testing of randomly selected parts at Hi-Rel
