Atlantis STS-110

SSME Flight Readiness Review

March 26, 2002

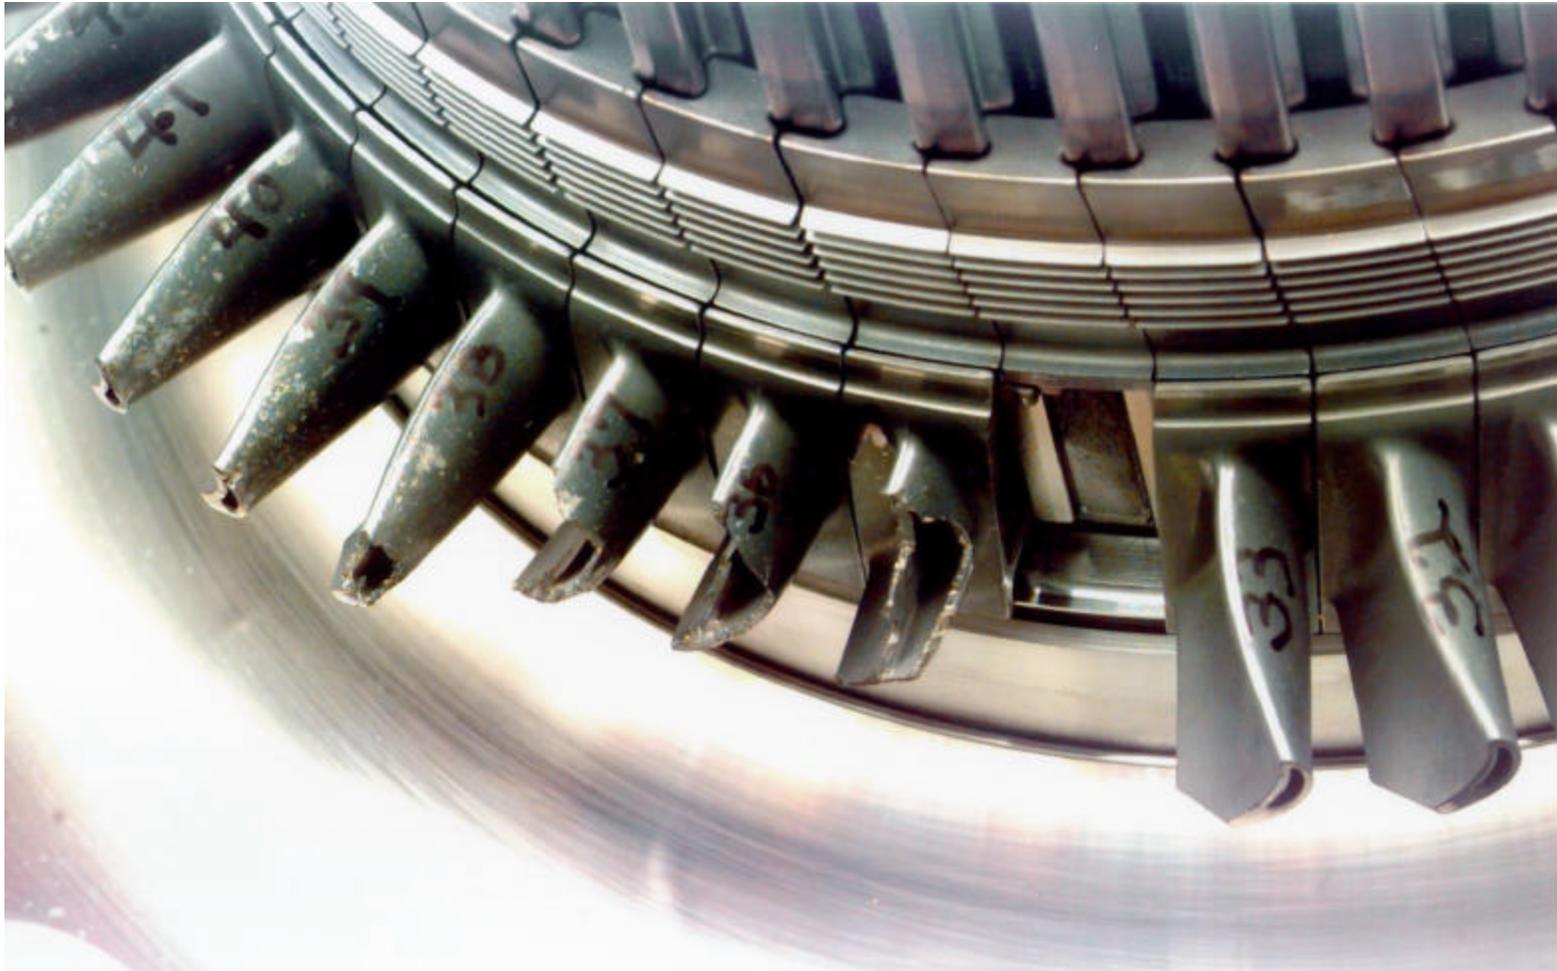
Blade Cracking Failure – 7/1/96

Damaged Turbine Blades (8-1a)

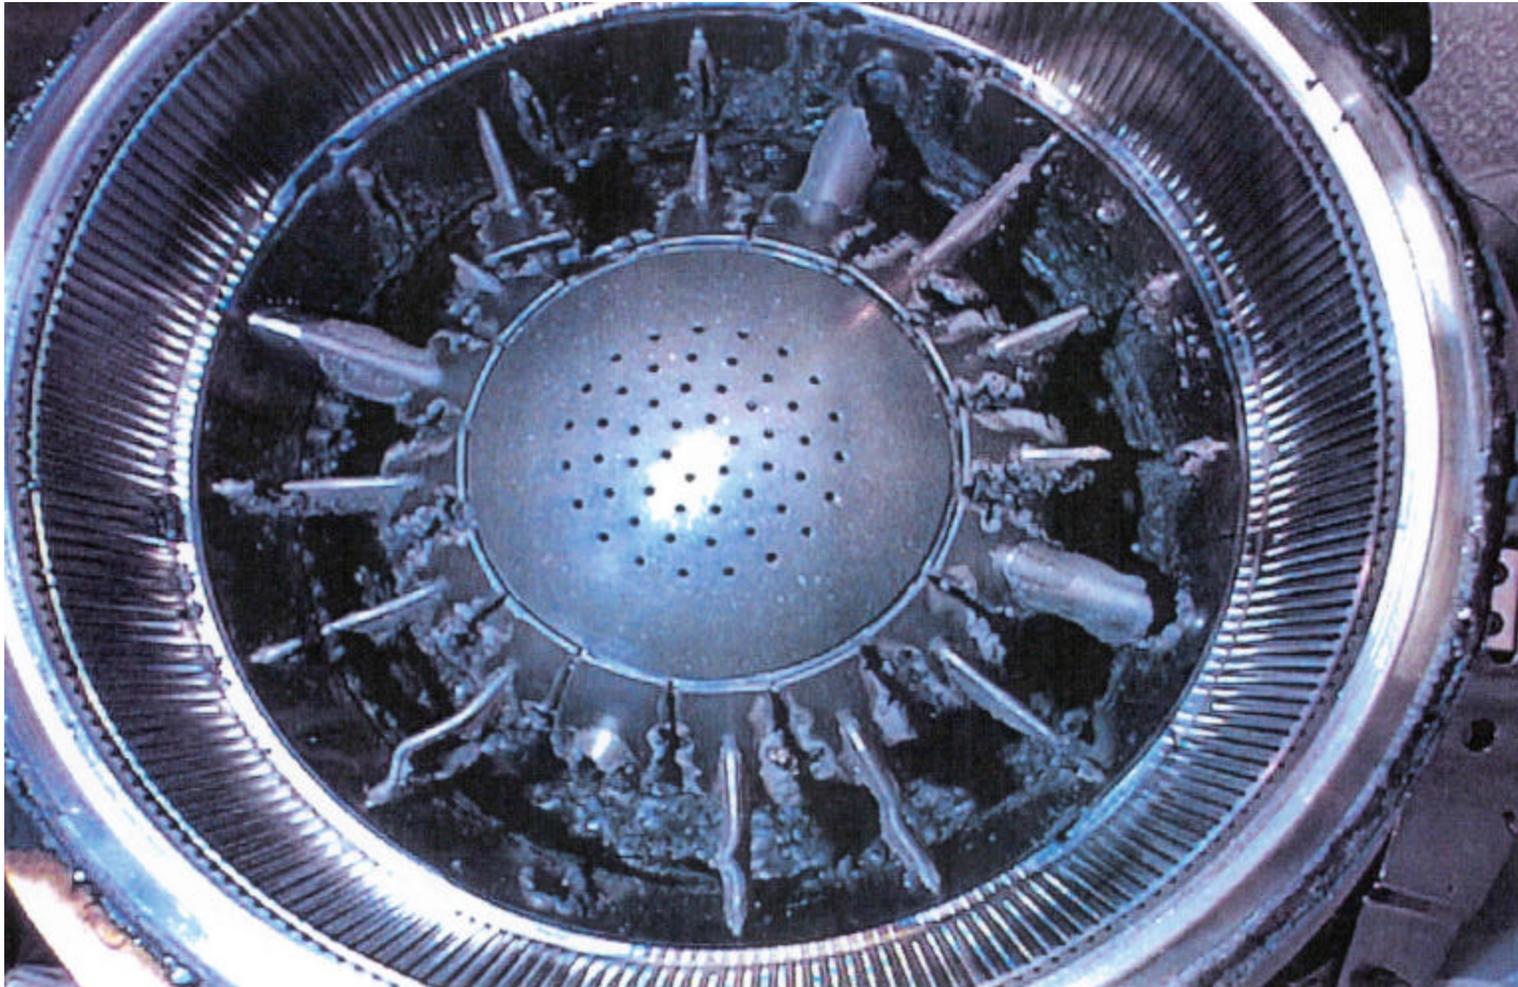
Nozzle Tube Rupture - 8/27/97

Damaged Turbine - SSME 0524

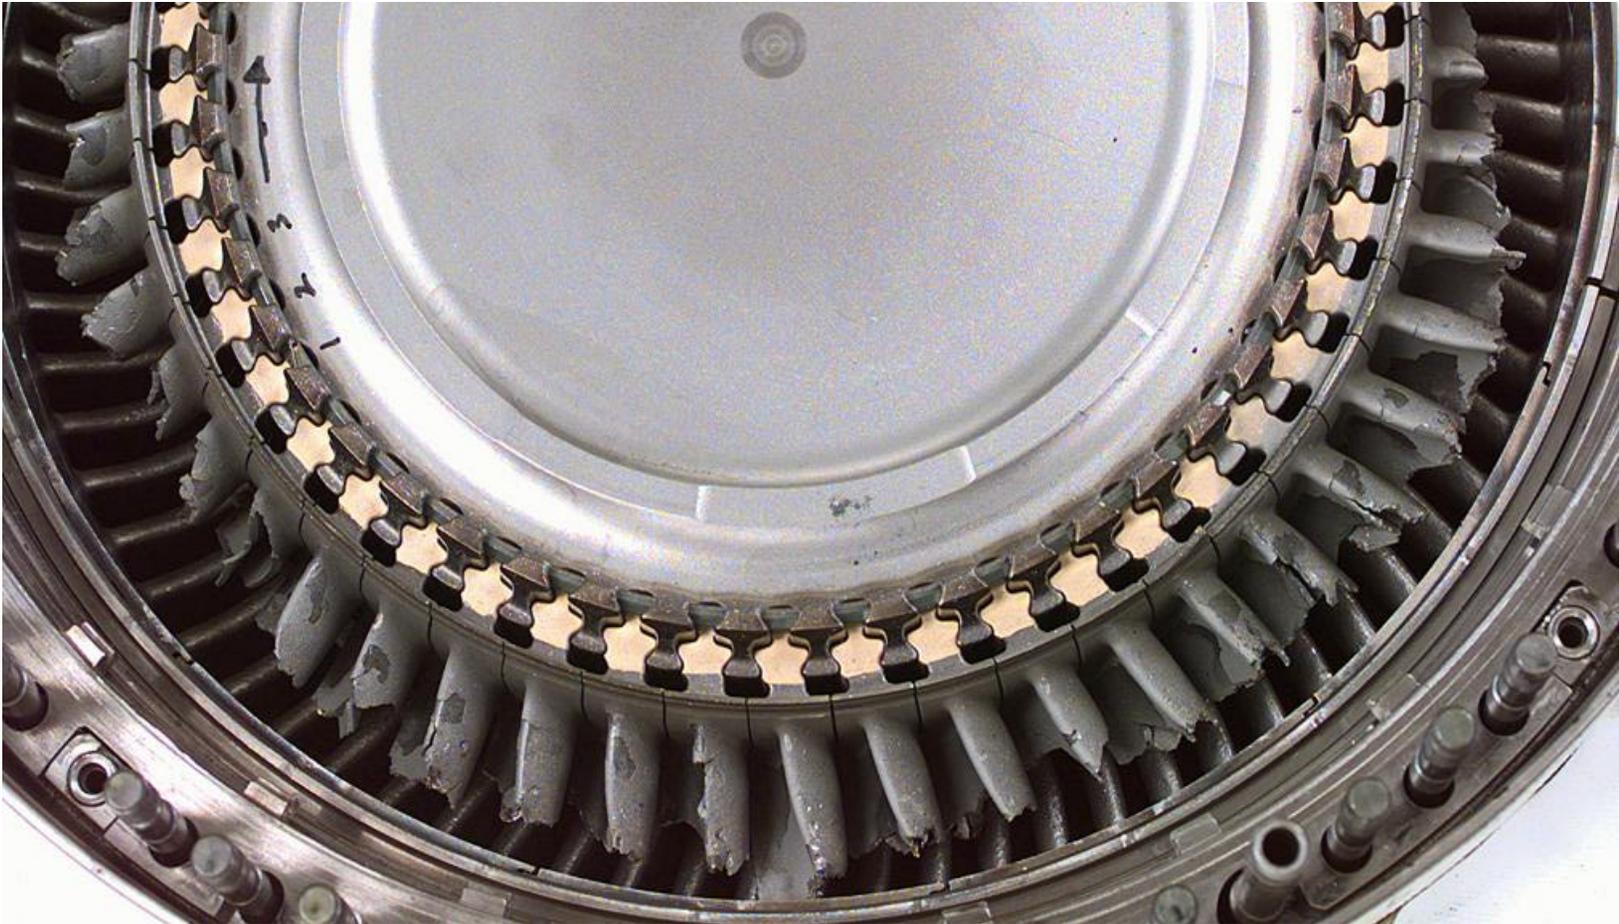
Foreign Object Obstruction in Fuel Preburner - 6/16/00

Damaged Turbine - SSME 0523

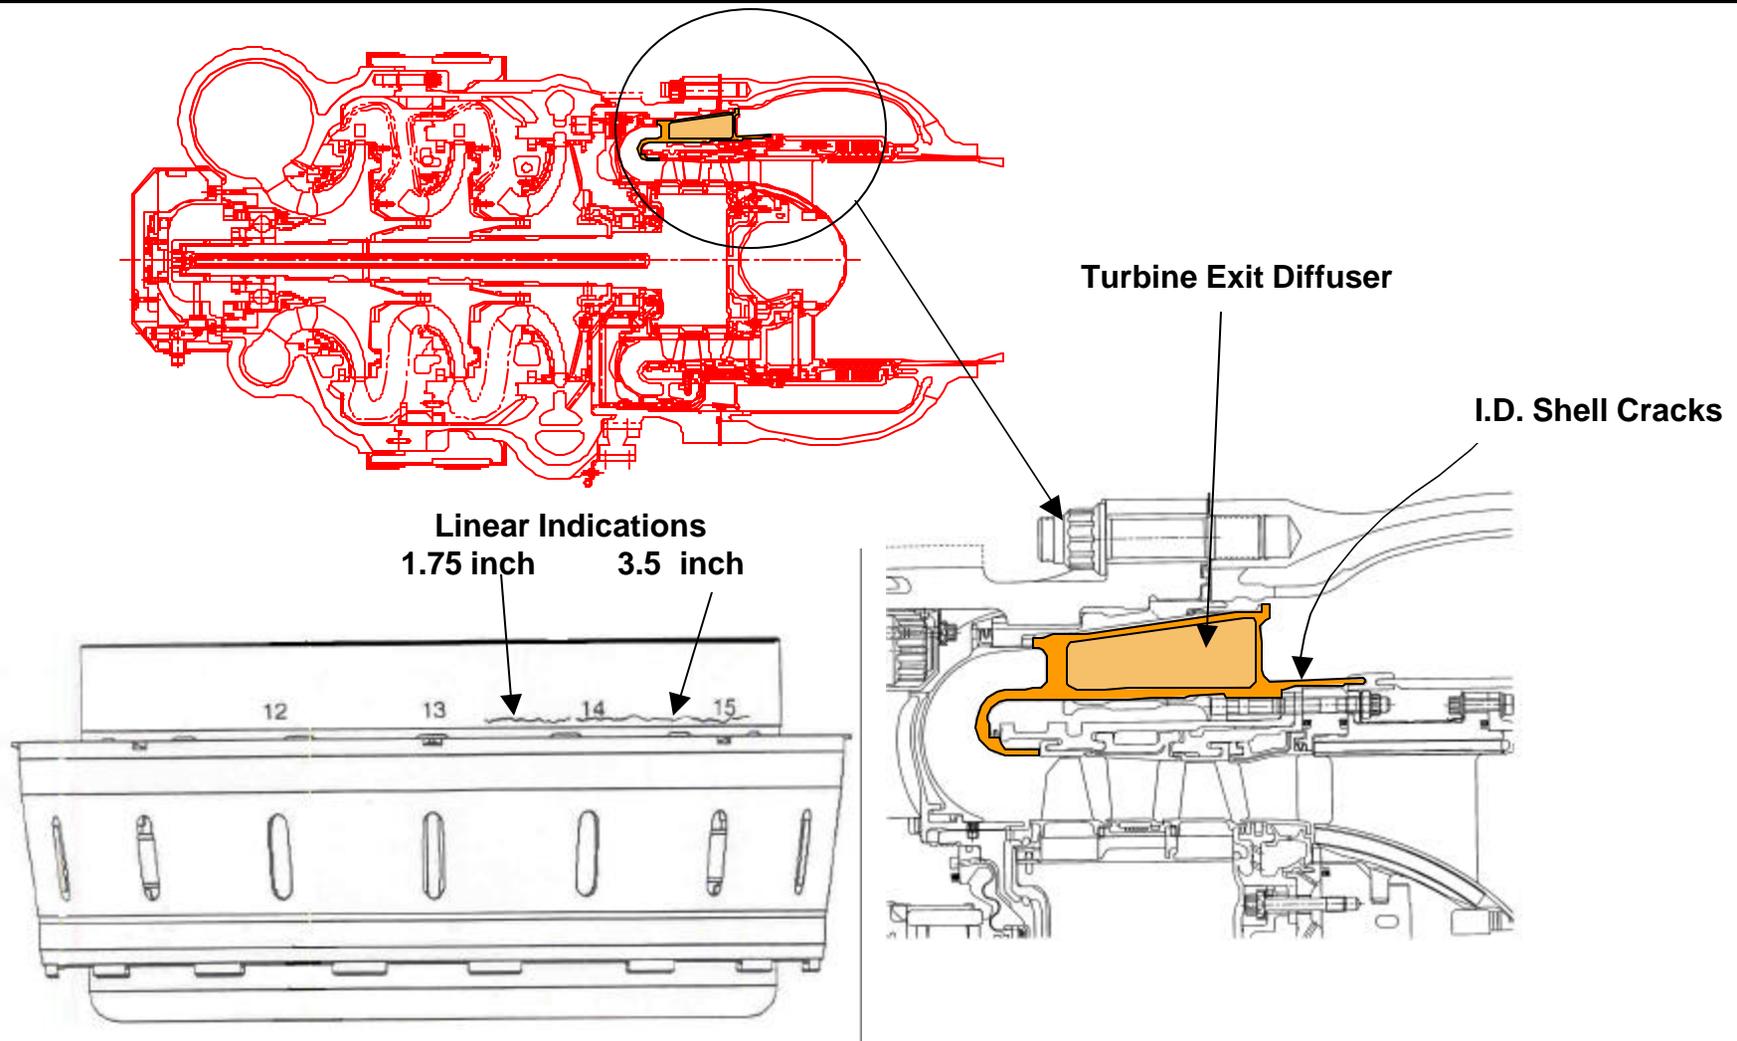
Block II HPFTP Turbine Exit Diffuser

- **Issue**
 - Cracking of the Turbine Exit Diffuser (TED) may result in turbine bypass
- **Background**
 - Circumferential cracks up to 3.7 inches long found on TED I.D. shell (flowpath side)
 - First occurrence at this location
 - Cracks appear to be through wall
 - Cracks found during FPI disassembly inspections of HPFTP 8210R1
 - TED accumulated 33 starts/ 20,881 seconds
 - 4683 seconds at 109% RPL
 - Six - 1000 second extended duration tests
 - TED continued to operate acceptably with no notable performance or structural issues

I.D. Shell Cracks

- **Flight Rationale**
 - Flight units maintain large margin over cracked unit
 - Will have accumulated 9% of cracked unit experience after its next flight
 - Extensive operational experience with no significant performance or structural issues

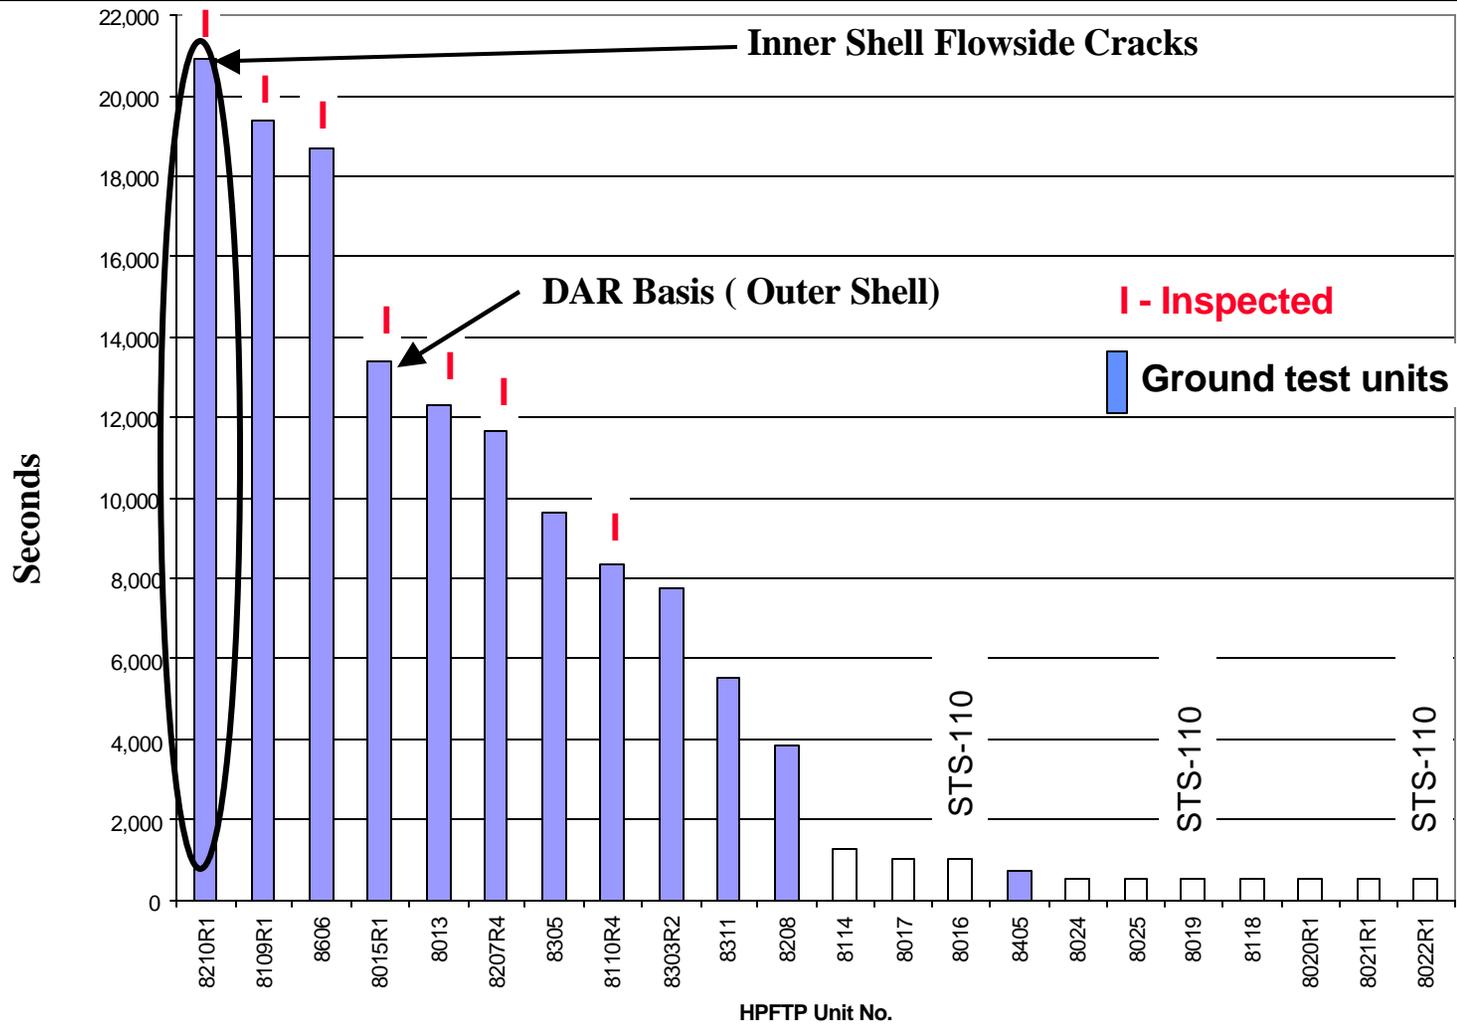
Block II HPFTP Turbine Exit Diffuser

- **Investigation**
 - Cracked TED used in HPFTP 8012 (Certification) for 22 starts/ 12,161 seconds
 - No I.D. shell cracks noted
 - DAR requires inspection at 5 starts/ 3351 seconds
 - Cracking on TED from HPFTP 8015R1
 - Different location- Outer Shell
 - Highest time flight unit (8016) has 2 starts /1032 seconds
 - Will have accumulated 8.6% of cracked unit total time after its next flight
 - Will have accumulated 9.1% of cracked unit total starts after its next flight

I.D. Shell Cracks

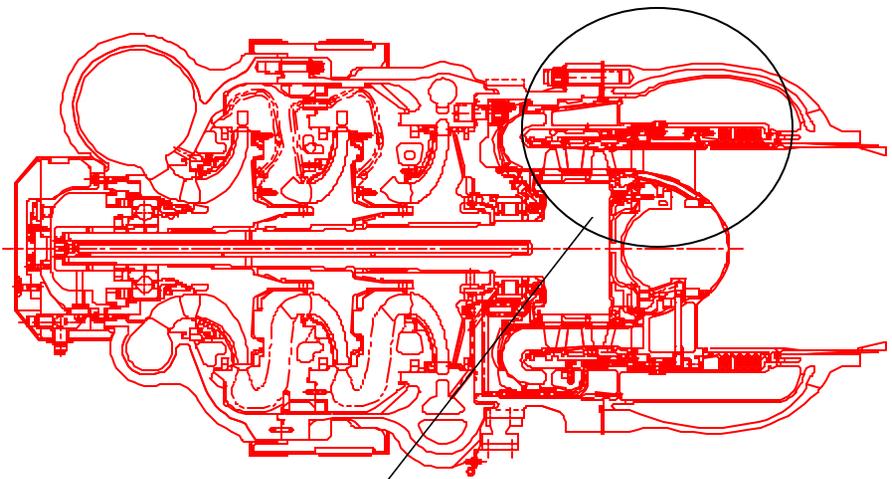
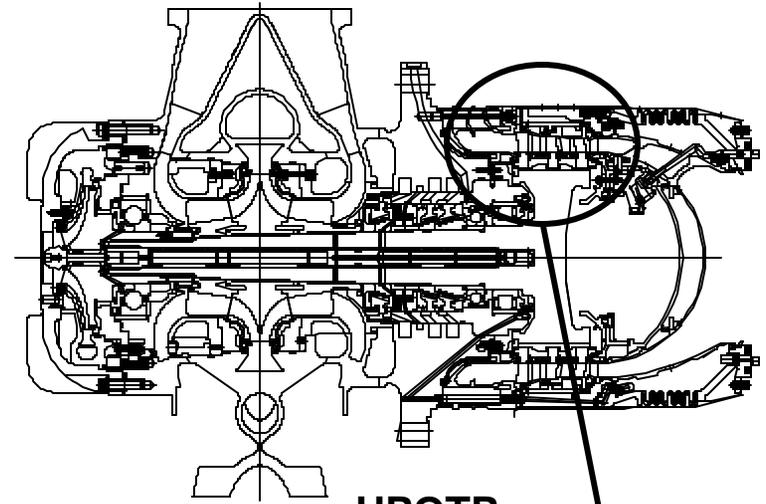
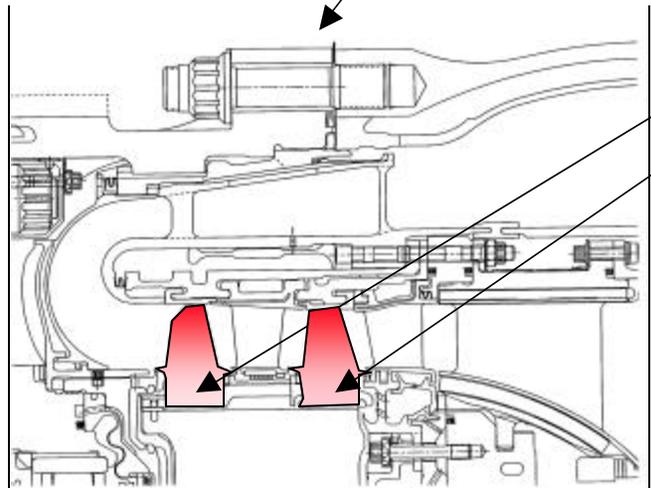
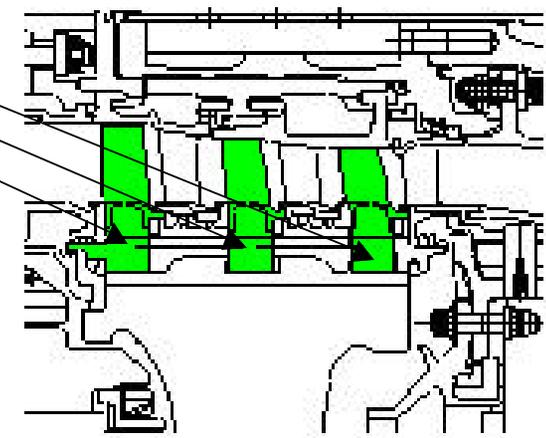
Block II HPFTP/HPOTP Turbine Blade

- HPFTP turbine blades shot peened without formal Engineering Source Approval (ESA) process control
- HPOTP turbine blades shot peened with unapproved shot media

- Turbine blade shot peened by sub-tier supplier - Impact Finishers
- Audit of HPFTP blades revealed no P&W approved shot peening set-up process sheets
 - ESA granted shot peen process approval of prime supplier without requisite shot peen process sheet review and approval at sub-tier supplier
 - Current shot peening supplier has processed all production turbopump blades (certification/flight)

- Flight blades have been shot peened with the same process as development and certification blades
 - Peening intensity is verified by test strip deflections
 - Shot peen coverage has been verified by inspection of blades and test strips
- Extensive hot fire experience with no performance or out of family conditions

- Peening intensity and coverage verified for both shot media
- Significant development test experience for both media
 - No out of family conditions
