STS-112 / 9A Flight Readiness Review

**George G. Guirgis
Glenn C. Lutz
EVA Project Office
Johnson Space Center
September 17, 2002**

EMU Battery Issues

Pistol Grip Tool Low Torque

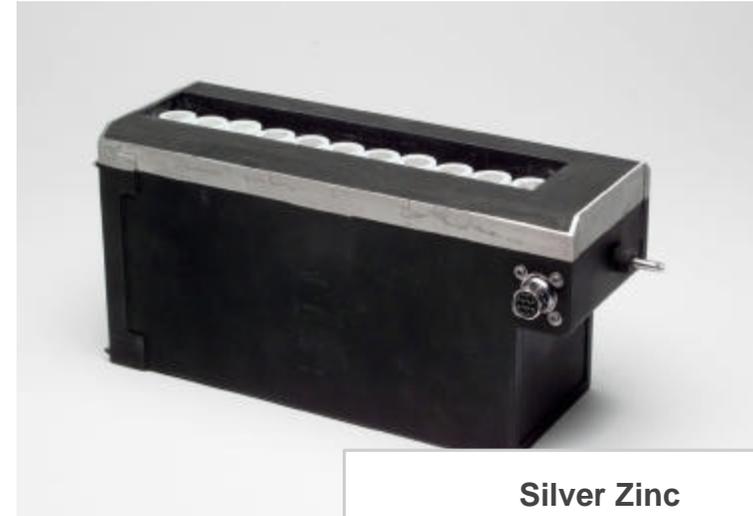
- EMU Increased Capacity Batteries (ICB's) have experienced several instances of less than expected capacity
 - Most dramatic was S/N 2022 which had rapidly dropping voltage during STS-111 / UF2 EVA2. EVA was successfully completed however, battery capacity was less than the EVA requirement.

Silver Zinc
Increased Capacity Battery

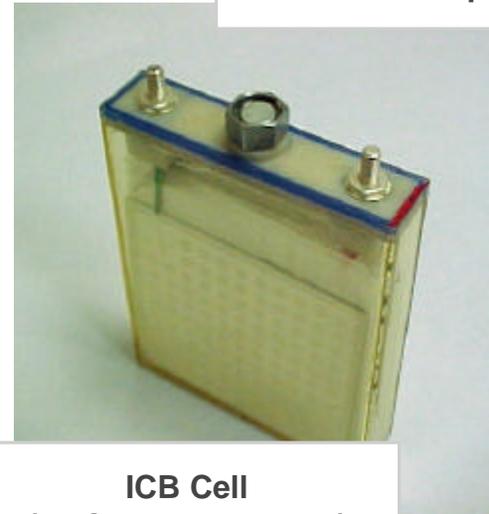
ICB Cell
(11 Cells Per Battery)

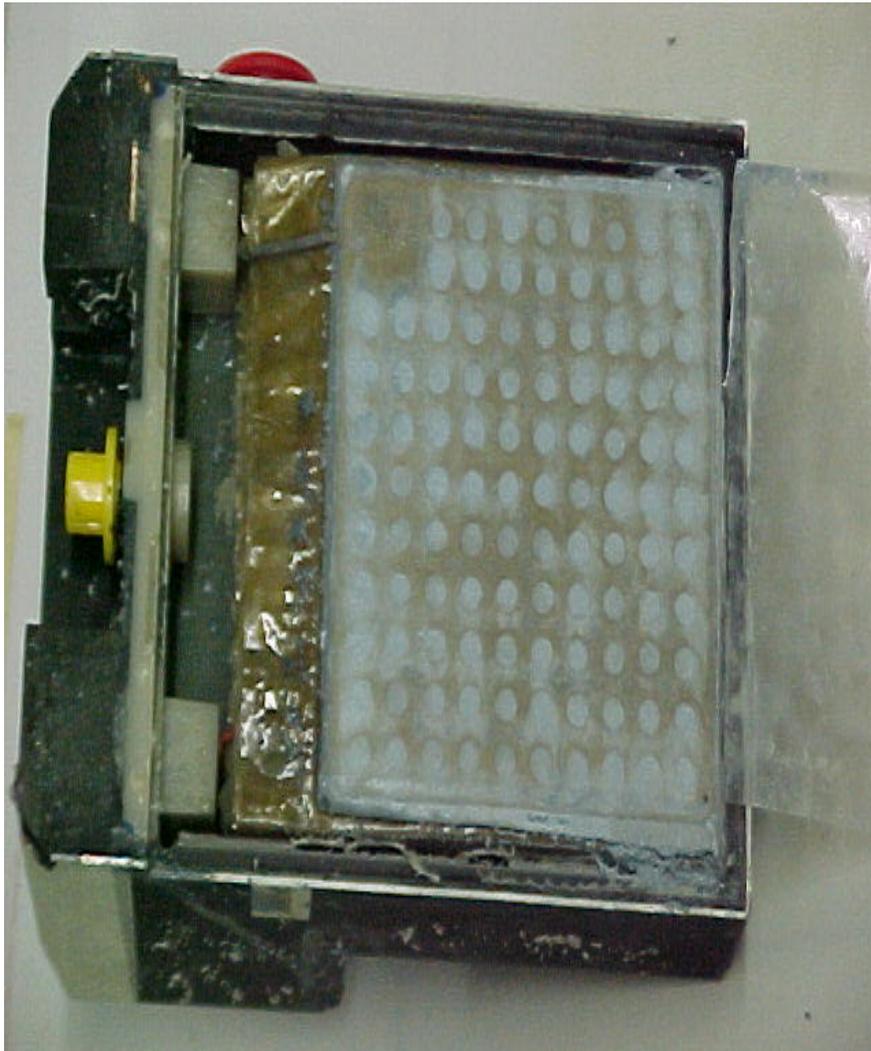
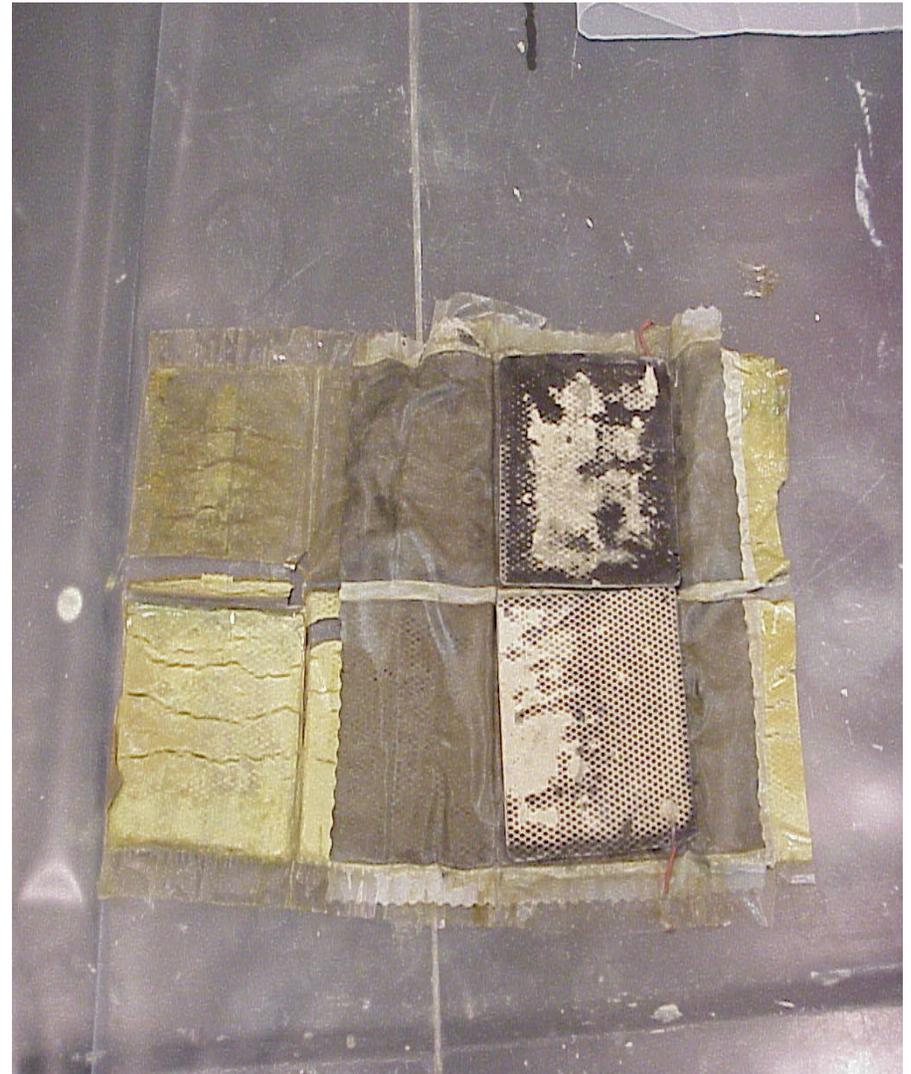
EMU Battery Cell Diagram

- Battery Summit was held at JSC on July 23–26, 2002, to understand issues with EMU battery capacity
- Have identified three (3) most probable root causes for the anomaly experienced (less than expected capacity)

- Interrupted charging
 - Occurs when battery charging is interrupted before voltage reaches maximum
 - » Results in 10 percent permanent loss of capacity

- Storage in semi-charged state
 - Previous battery experience considered that a silver zinc battery was discharged after an EVA
 - » Recent experience has shown that sufficient power remains after an EVA to degrade future battery performance (growth of oxalate crystals causing internal anode-cathode shorts)

- Self-Discharge
 - Loss not considered a factor in the past due to short Shuttle flights, EMU checkout top-off charges and ground processing freezer storage

- » Loss can become significant with storage aboard ISS (estimated to be ~5 percent capacity loss per month)

- Four (4) newly processed EMU batteries being brought to ISS on STS-112/9A and left behind for increment stage.
 - All EMU batteries on ISS are being brought back on STS-112/9A
 - All EMU batteries will support Shuttle contingency EVA operations
- All increment batteries will be maintained per summit recommendations
 - Stowed discharged for long dormant periods greater than 50 days
 - Cycled every 85 days to retard / control crystal growth
 - Charge continuously (no interrupted charging) when required for EVA support

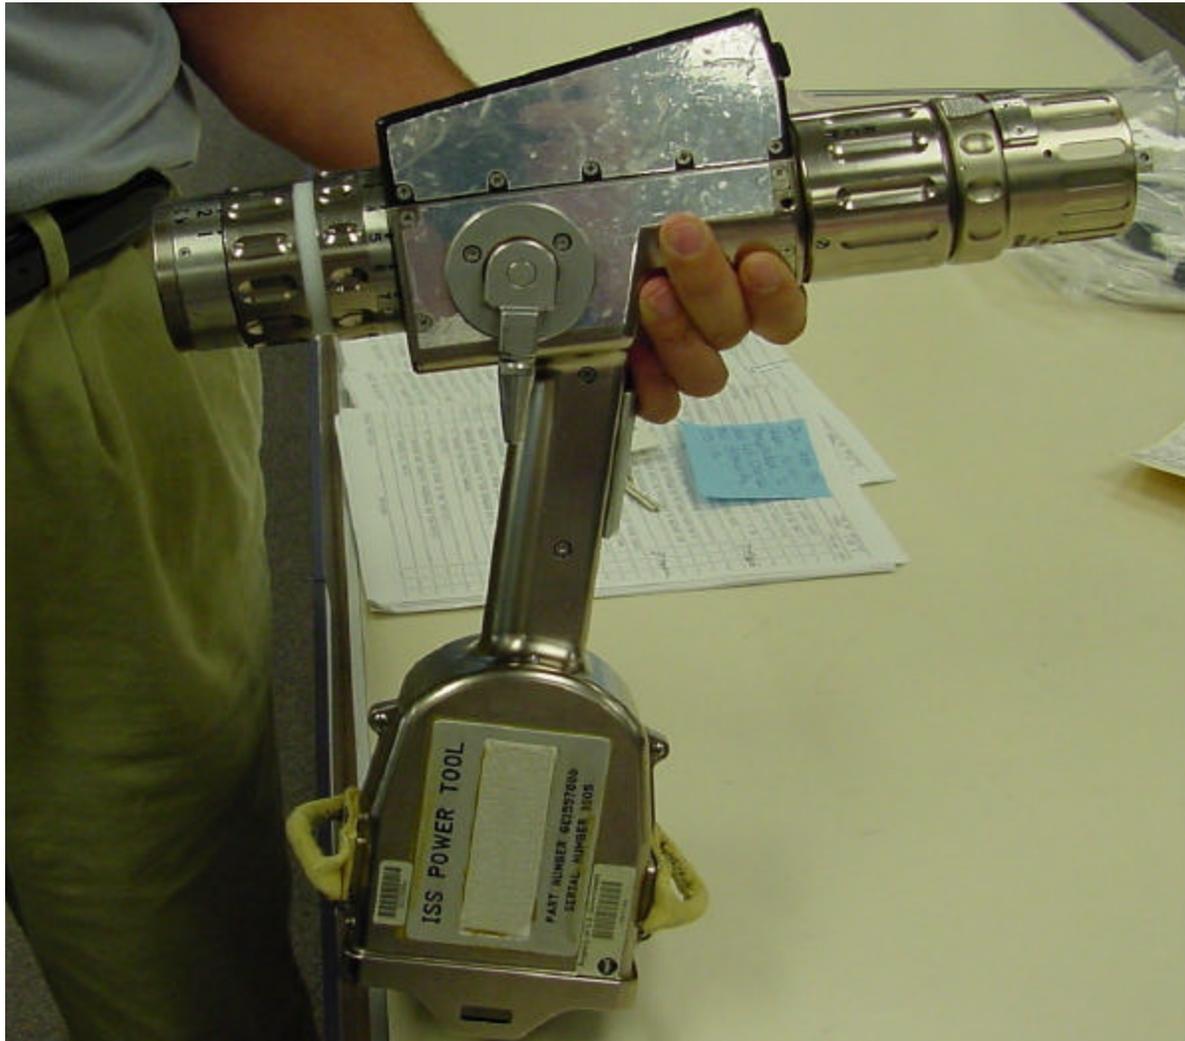
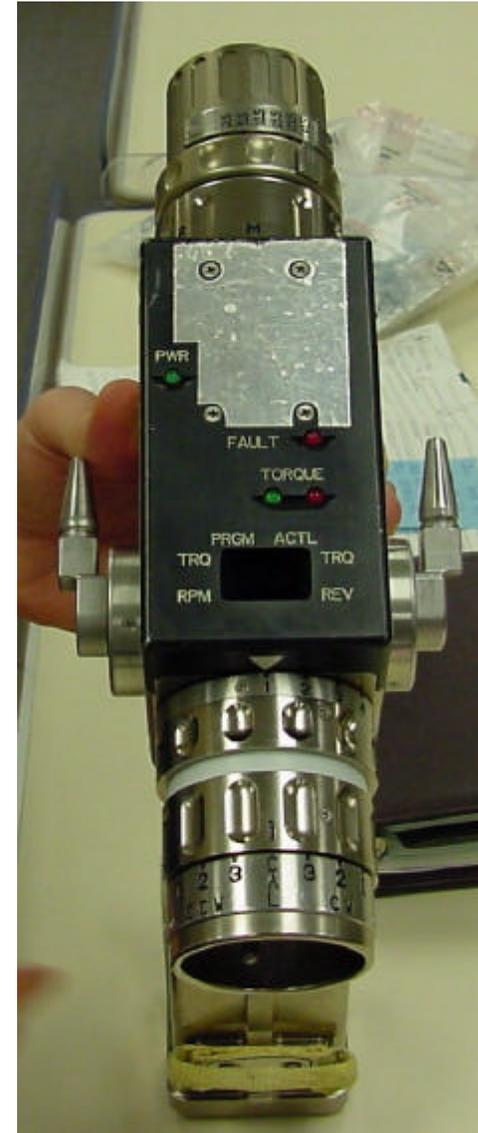
PGT-Low Torque

- Pistol Grip Tool (PGT) S/N 1007 was found to be out-of-spec for low torque during post UF-2 flight testing

- Review of historical data shows S/N 1007 has always tested near bottom of specification band compared to remainder of fleet #1007 is historically the lowest performer of the tools (Spec: ± 1.0 ft-lb below 10 ft-lb and ± 10 % above 10 ft-lb)

S/N 1007 post-flight test results are not significantly out of family for this tool

- Subsequent testing resulted in verifying out-of-spec conditions on two independent test stands but at lower frequency and magnitude (~.5 ft.- lbs. out of limits, with one data point at .69 ft.-lbs. out of limits)

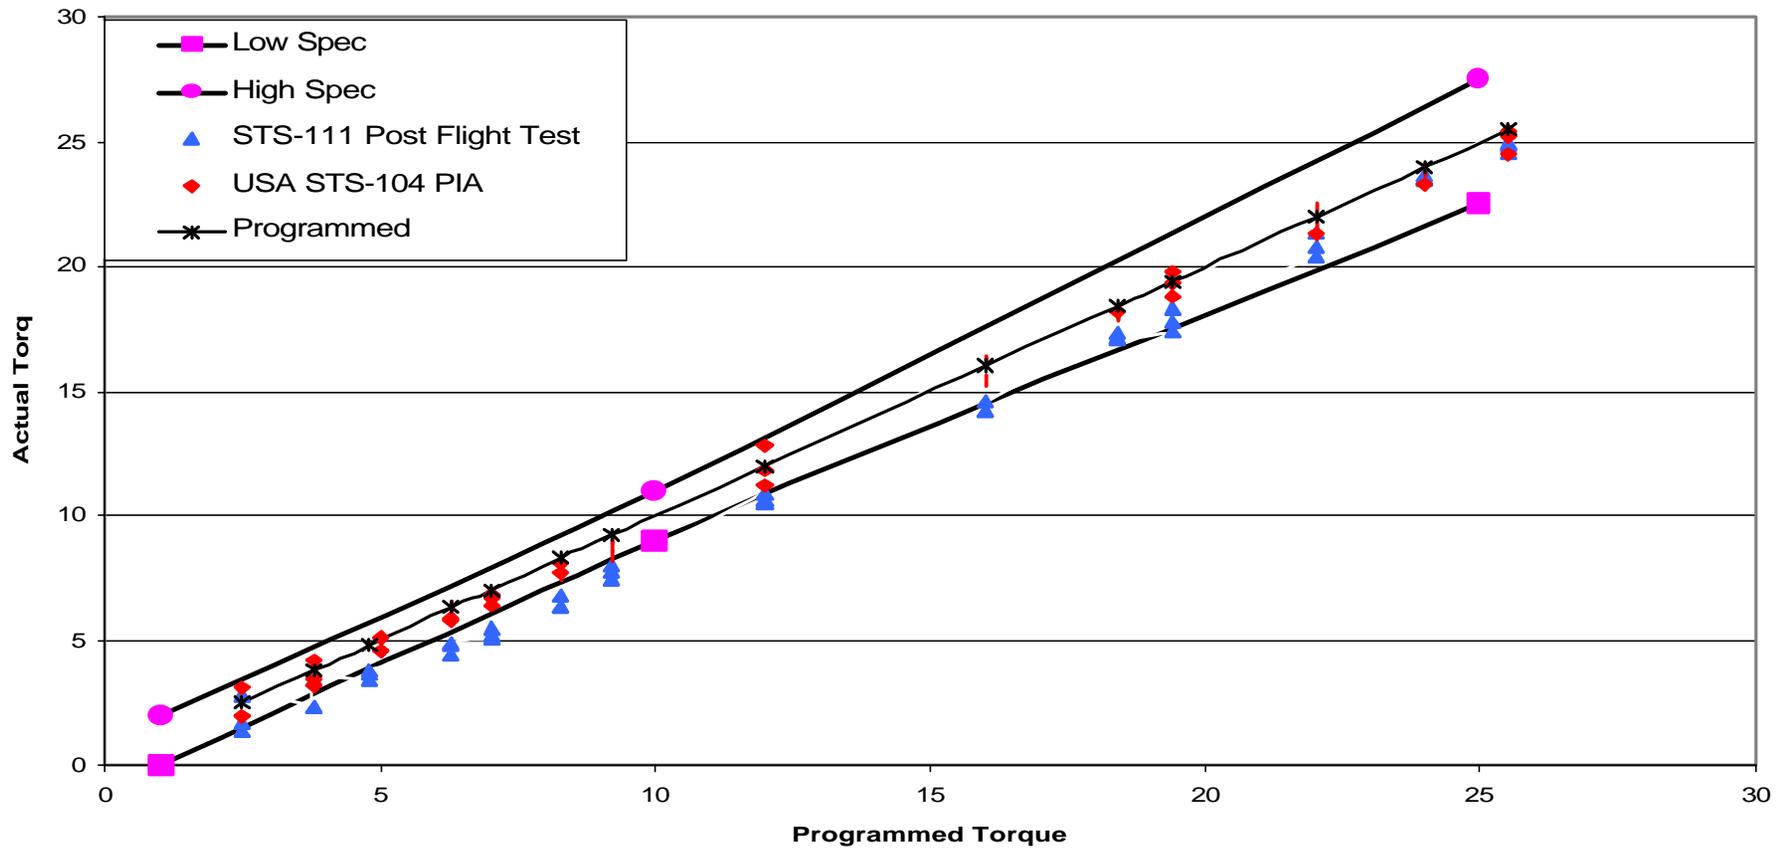
Serial 1007 Performance

PGT S/N 1007 Last Passed PIA (pre STS-104) and failed Post Flight Testing (post STS-111)
