**STS-113**  
**FLIGHT READINESS REVIEW**

**October 31, 2002**

**Ground Operations**

<b>ENGINEERING TOPIC: STS-112 HOLD DOWN POST SYSTEM A PYRO FAILURE</b>	<b>Presenter: John Cipolletti</b>
	<b>Organization/Date: Ground Ops/10-31-02</b>

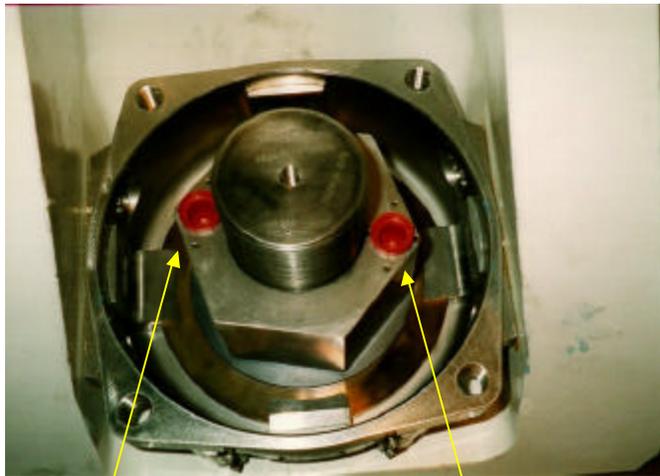
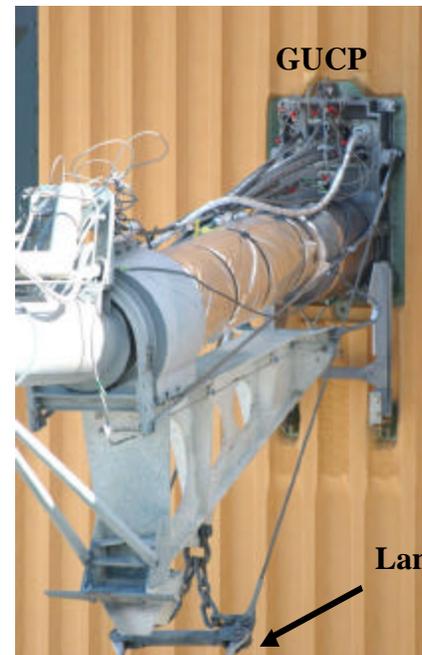
**HDP Stud with Frangible Nut**

**NSI 1 Provision**

**NSI 2 Provision**

**ET Vent Arm System**

**Lanyard Attach Point**

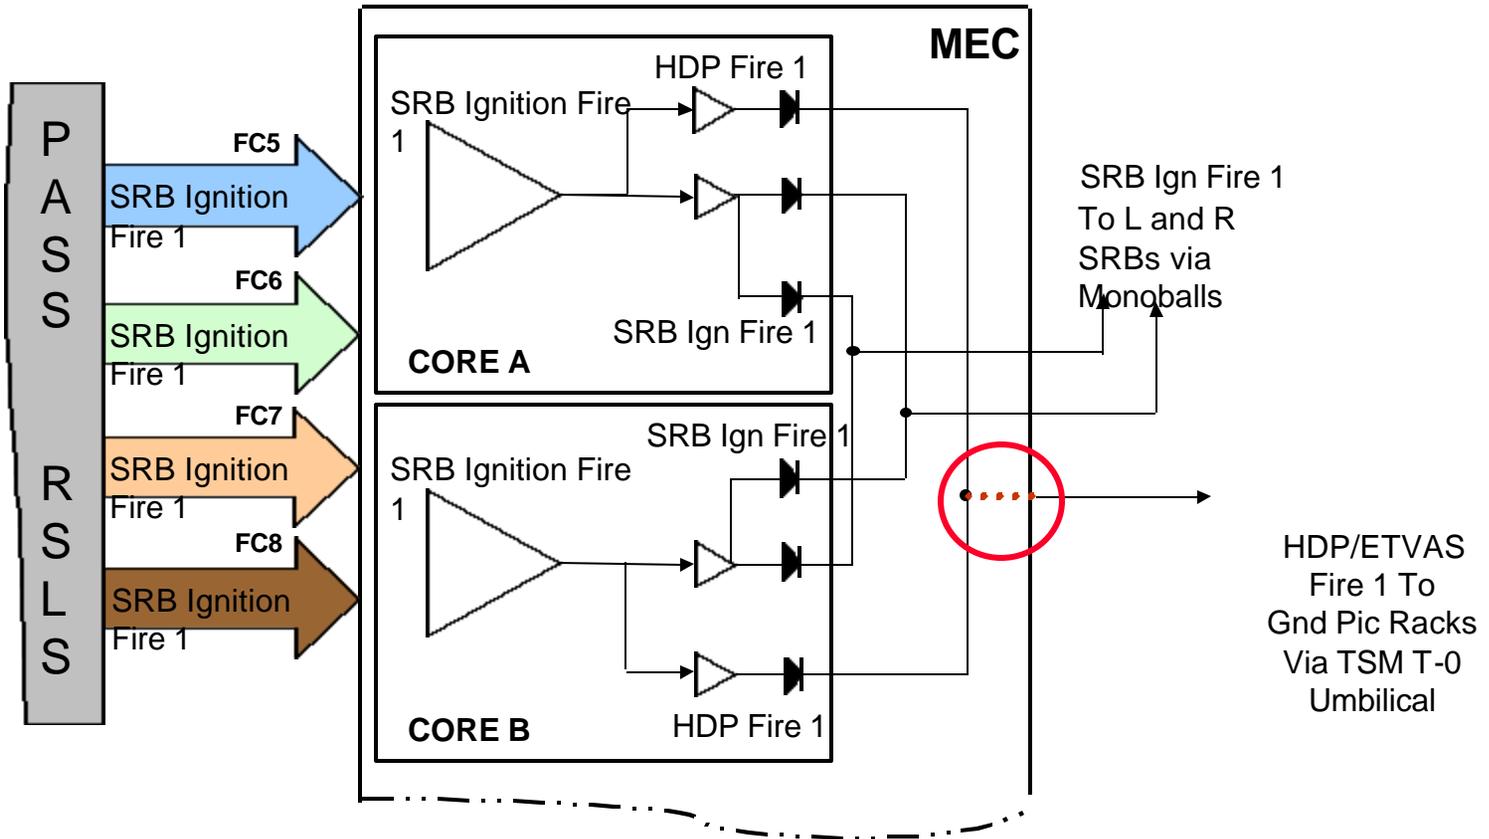
**MEC SRB Ignition Fire 1 Command Set**

- Possible Causes (Cont'd)
  - The MEC can be eliminated as a possible cause of the anomaly
    - A MEC 1 Core processing failure can be eliminated
      - MEC 1 correctly processed the SRB Ignition command
      - Incorrect HDP processing requires two simultaneous, intermittent like failures
    - MEC 1 driver output failure can be eliminated
      - Testing indicates diodes are intact
      - Two simultaneous, intermittent failures would be required
    - One common wire path for this command exists within the MEC has been cleared
      - Static testing shows the common path to be intact and MEC output of ARM, Fire 1, and Fire 2 commands has been verified
      - Dynamic stability of internal wiring has been verified. MEC s/n 10 was removed from the MEC 1 position and passed ATP with vibration

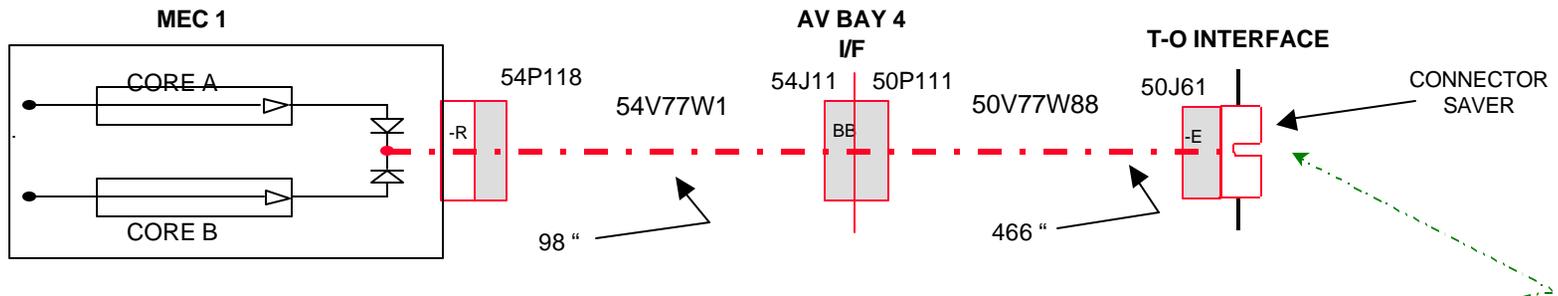
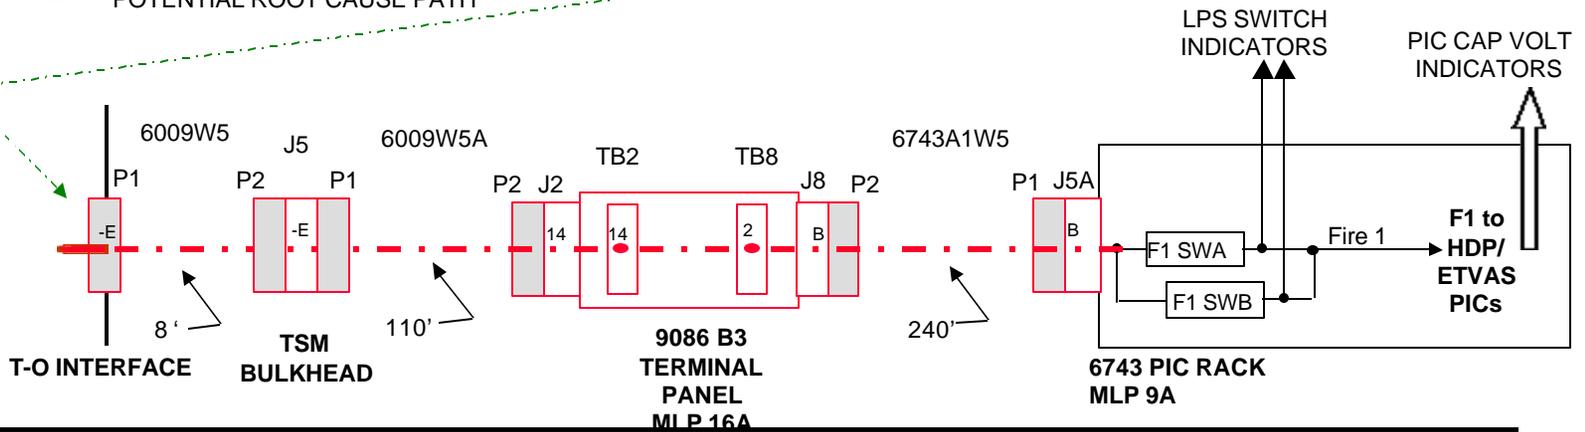
## SYSTEM A HDP / ETVAS Fire 1 Command Path

- Possible Causes (Cont'd)
  - The Fire 1 command was not transmitted properly from MEC 1 to PIC Rack 6743 in the MLP
    - There is a single copper path for the Fire 1 command from MEC 1 to the PIC Rack that crosses the T-0 interface
    - There are three main sub-level contributors to this fault path
      - Orbiter wiring and connectors
      - T-0 Interface
      - Ground MLP wiring and connectors

- - - POTENTIAL ROOT CAUSE PATH

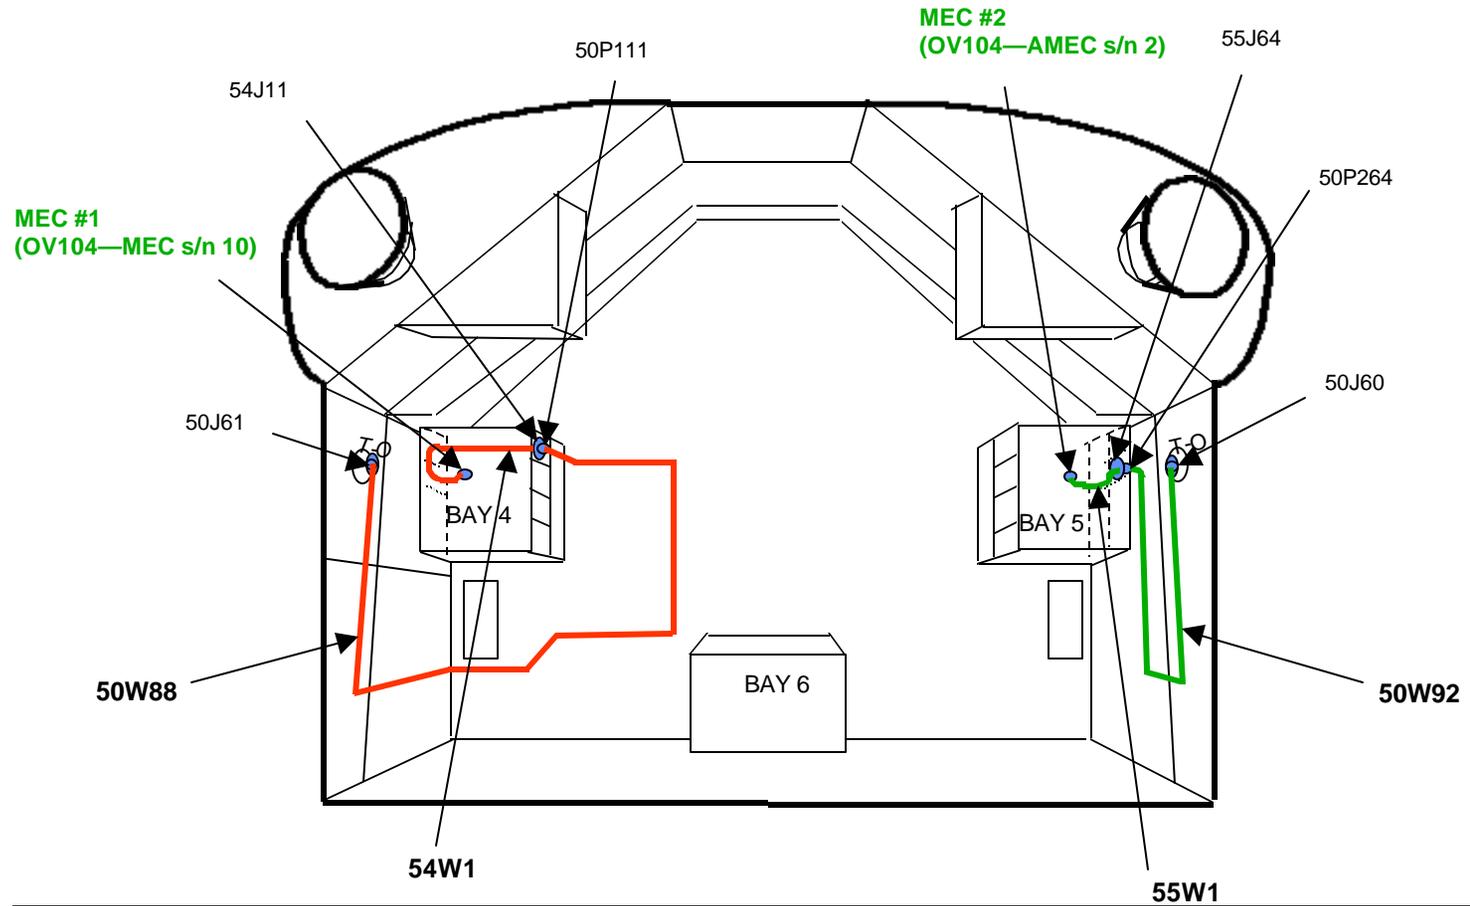
### MEC 1 and 2 to T-0 Wire Runs

- Possible Causes (Cont'd)
  - The Fire 1 command was not transmitted properly from MEC 1 to PIC Rack 6743 in the MLP – *Orbiter Wiring/Connectors*
  - Testing has not detected a problem in the Orbiter cabling and connectors under static conditions and while flexing cabling at connectors
    - ARM, Fire 1, and Fire 2 signals have been sent from MEC 1 and verified at the T-0 connector saver (50J61)
    - Isolation tests, continuity tests, and Dielectric Withstanding Voltage (DWV) tests have been conducted on the wire run between MEC 1 and the T-0 connector
      - Wire run 54W1 and 50W88 with associated connectors
      - DWV run at 1500 VDC, 0.5 mAmp
  - Replacement of the entire wire run is planned along with Failure Analysis of the removed components

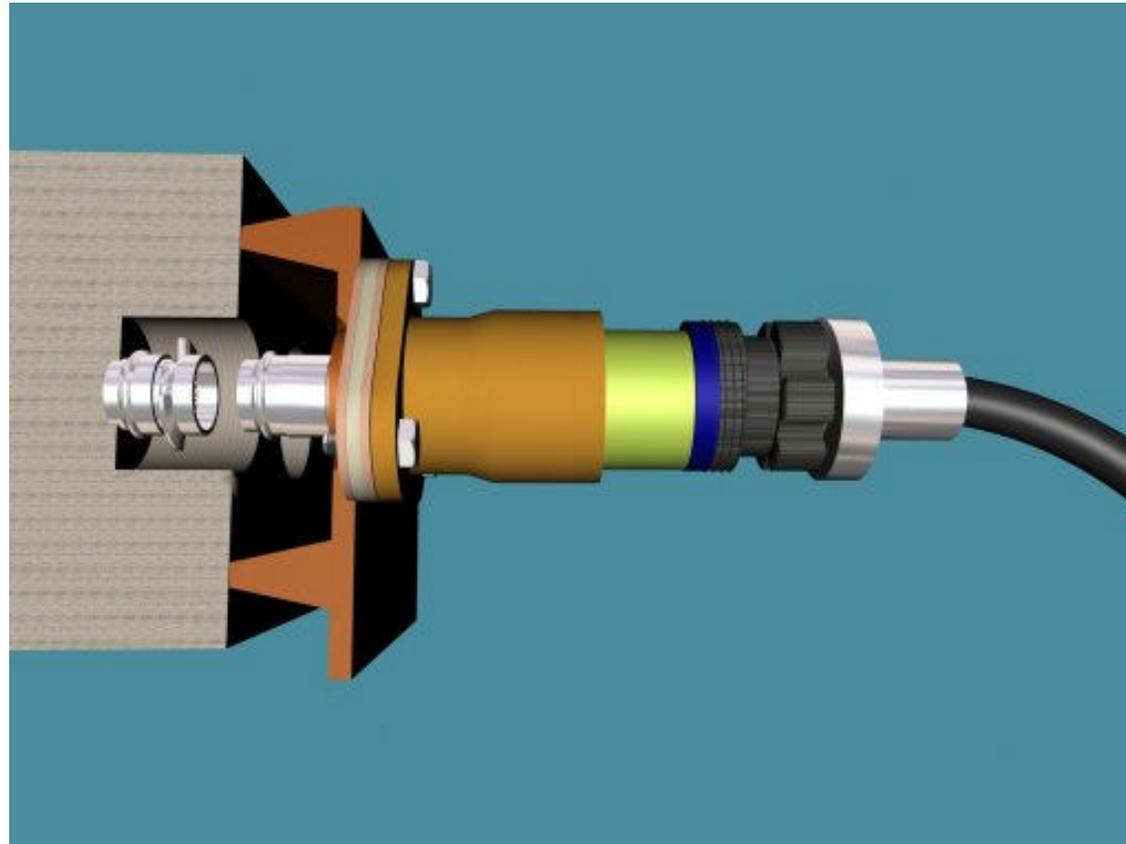
**Cut-Away Illustration of T-0 Connector Mate**

- Possible Causes (Cont'd)
  - The Fire 1 command was not transmitted properly from MEC 1 to PIC Rack 6743 in the MLP – *T-0 Interface*
  - The electrical connector remains as a possible cause
    - Visual inspection using 10x magnification detected contamination and missing gold plating on the 6009W5 P1 connector pins
    - Orbiter connector saver showed no discrepancies under 10x inspection
    - Pressure Spring constant was determined to be 30.5 lb/in, drawing requirement for new spring is 34.9 lb/in
    - Pin/socket engagement was examined under x-ray and determined to be within specification at 3.6 mm
    - Further analysis of all components is planned

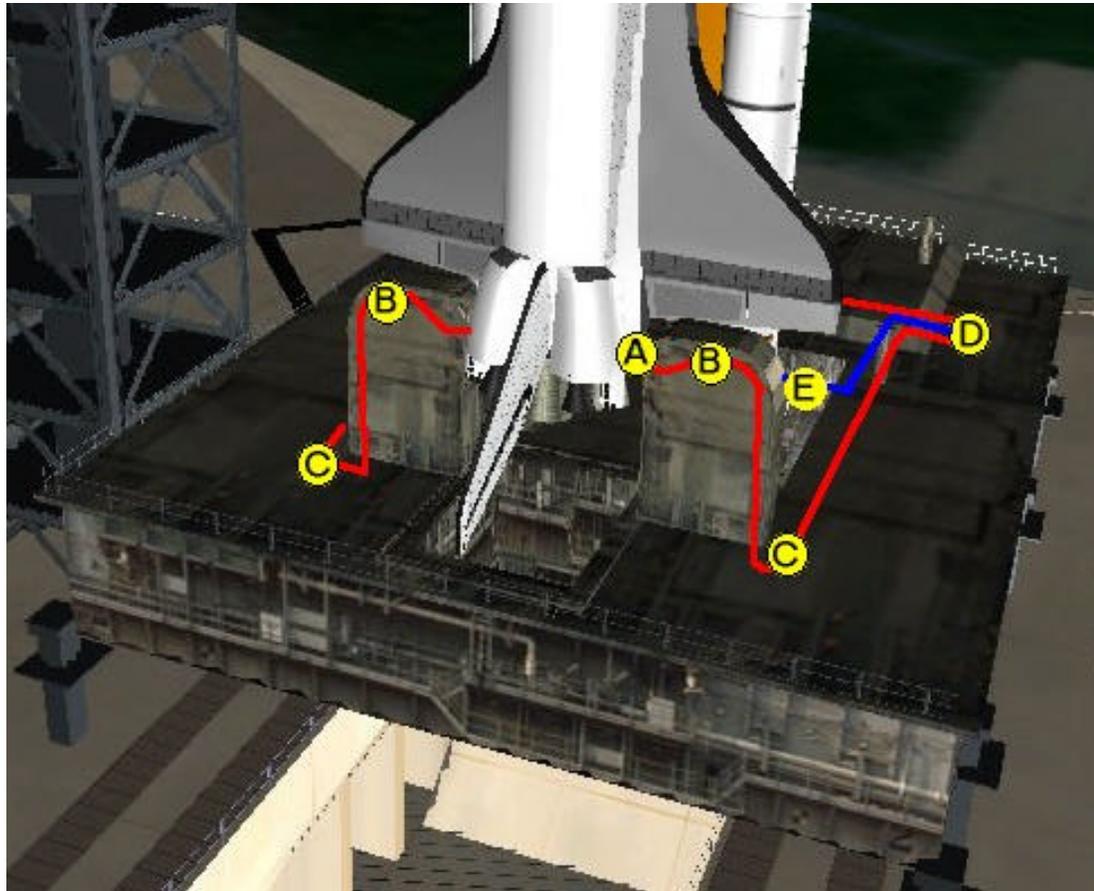
**MLP T-0 To Hold Down Post Wire Runs**

- Possible Causes (Cont'd)
  - The Fire 1 command was not transmitted properly from MEC 1 to PIC Rack 6743 in the MLP – *MLP Wiring/Connectors*
  - Non-Destructive Failure Analysis is completed on MLP wire runs
    - Cable 6009W5 was removed and real-time radiography performed on the connectors and wire length. No anomalies noted
    - Cable 6009W5A was removed and x-ray analysis performed on suspect damage areas and connectors. No anomalies noted
    - Cable 6009W5 and 6009W5A were mated and real-time radiography and x-ray analysis performed on the mating interface
      - Normal pin insertion of 3.25 mm was measured

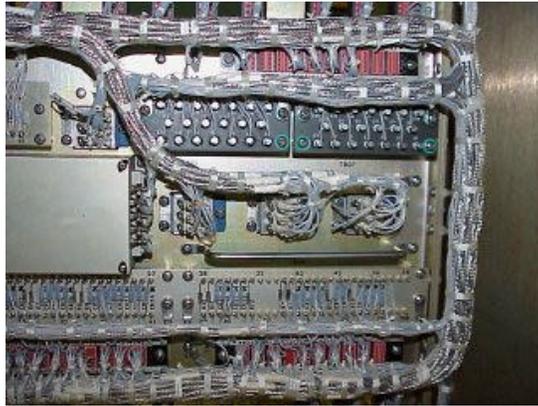
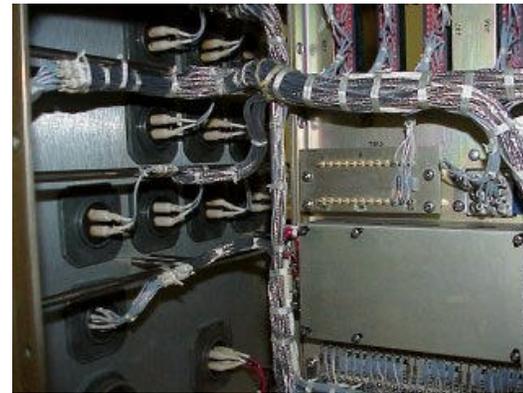
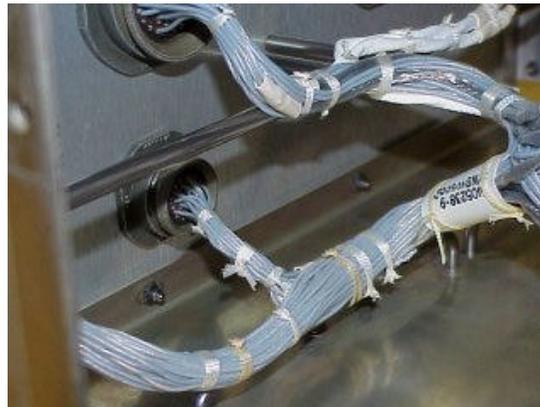
**Internal Photos of Spare CPA**

- Possible Causes (Cont'd)
  - The Fire 1 command was not transmitted properly from MEC 1 to PIC Rack 6743 in the MLP – *MLP Wiring/Connectors*
  - Failure of the PIC Rack CPA can be eliminated as a cause of this anomaly
    - PIC(s) responded within specification to ARM, Fire 1, and Fire 2 commands during testing
    - PIC Rack switching transistors responded to voltage/current levels well below MEC output capability (even with one driver failed)
      - Transition occurred at 14.4 VDC, 3 mA
      - Normal MEC output is 28 VDC, 20 mA
    - LRU level testing of CPA has been performed
      - Visual inspection of all components
      - Continuity check of all circuits, static and while flexing
      - IR and DWV of internal wiring
      - Inspected and performed retention test of junction module (Deutsch Block)

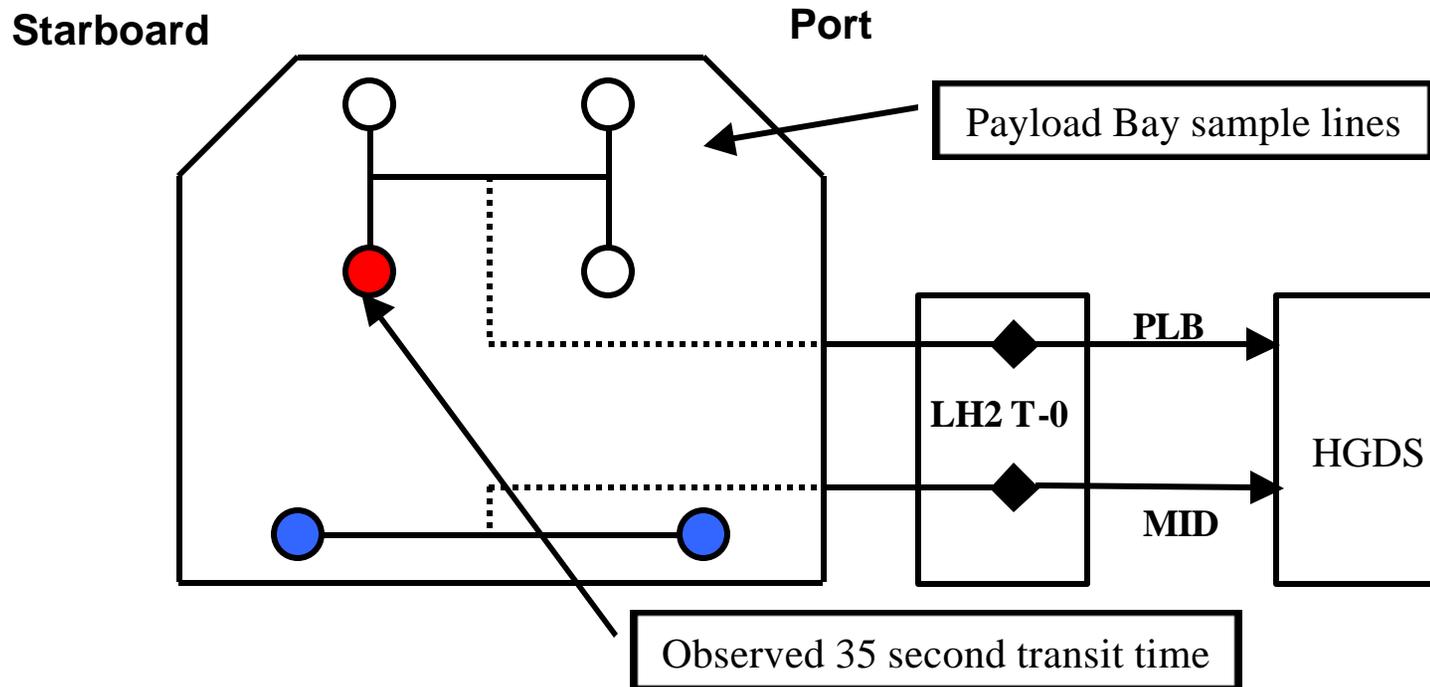
Aft 1307 bulkhead as seen from the Payload Bay side

- Discussion
  - Aft, Payload Bay, and Midbody HGDS sample lines
    - Verified every flow by injecting helium into Aft pickup tubes located at 1307 bulkhead
  - All four Payload Bay sample lines are equal lengths and merge into one line (homogenous mixture)
    - 1 of 4 sample lines supports Payload Bay sampling
- Actions Taken
  - Testing of four Payload Bay sample line was performed at Pad-A
    - Transit time acceptable at 17 seconds
    - Lower starboard sample line blow down indicated no contamination
    - Pressure decay verified integrity of line (no leaks)
    - Performed test with Payload Bay doors closed (original configuration of initial problem)
      - Transit times nominal (actual - 17 seconds)

- Actions Planned
  - HGDS troubleshooting prior to S0007
    - Remove Flow Splitting Panel (FSP) from MLP HGDS
      - Analyze for contaminants
    - Perform blow down of GSE hose from FSP to T-0 interface
      - Capture and sample possible debris
    - Re-perform Payload Bay transit times (lower ports only)
