**STS-100
FLIGHT READINESS REVIEW**

APRIL 5, 2001

ORBITER

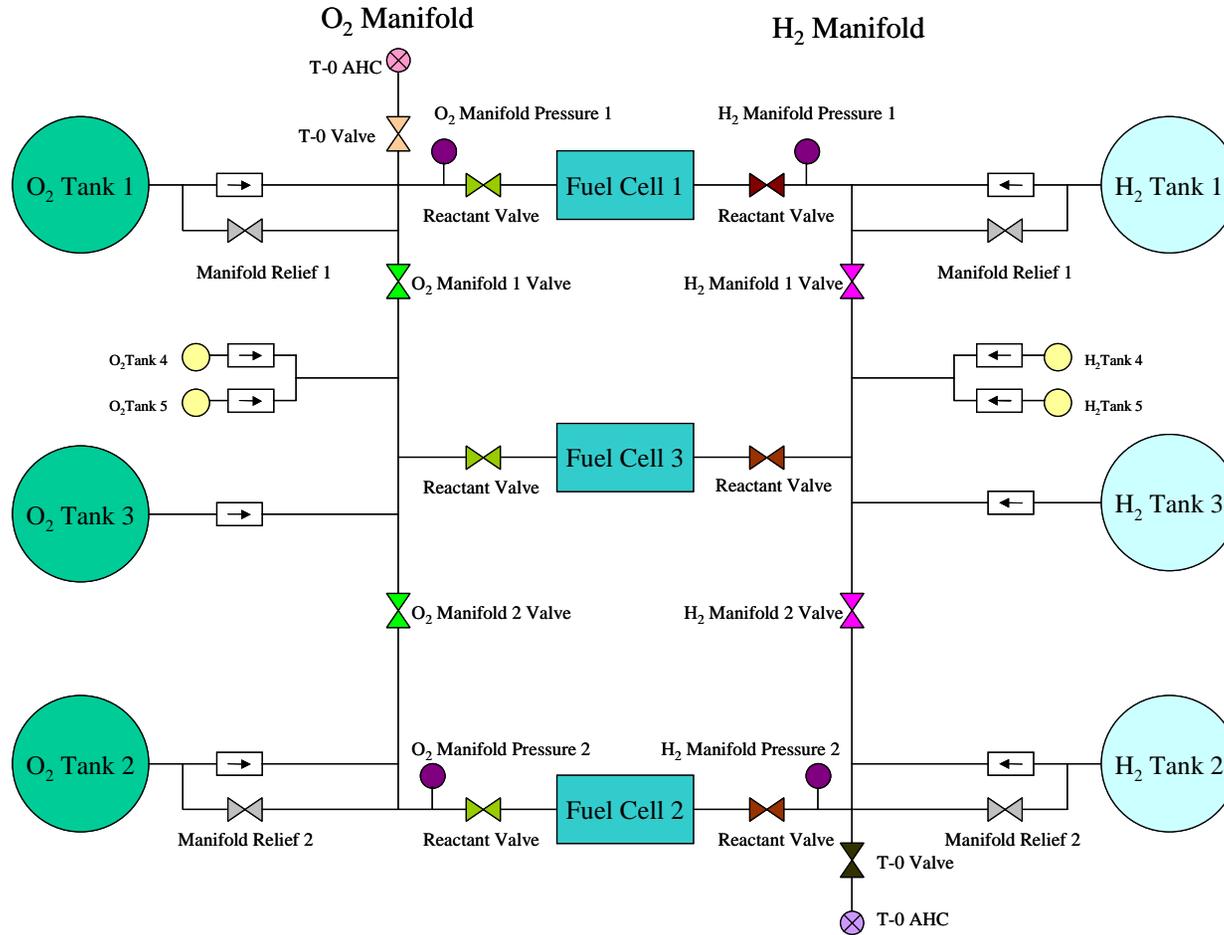
PRSD System Schematic

- All OV-105 valve housings / seats were assembled in 1989/1990 time period
- Manifold #1 H₂ panel was installed at Palmdale during vehicle build (7/1990) and has flown all 15 OV-105 missions with only in-spec leakage
- Leak test history (sccm):

- Leak test history of both of OV-105's H₂ panels show leakage rates well within component spec
 - No indication of cracked seats
- Individual valve leakages will be verified before flight
- No potential for particle generation that prevents valve operation
- No potential for valve seat failure resulting in gross leakage
- No safety or operational issues exist, even with out-of-spec internal leakage

- Failure analysis to be completed
- Need for long term corrective action to be determined
