**STS-109  
FLIGHT READINESS REVIEW**

**FEBRUARY 14, 2002**

**Orbiter**

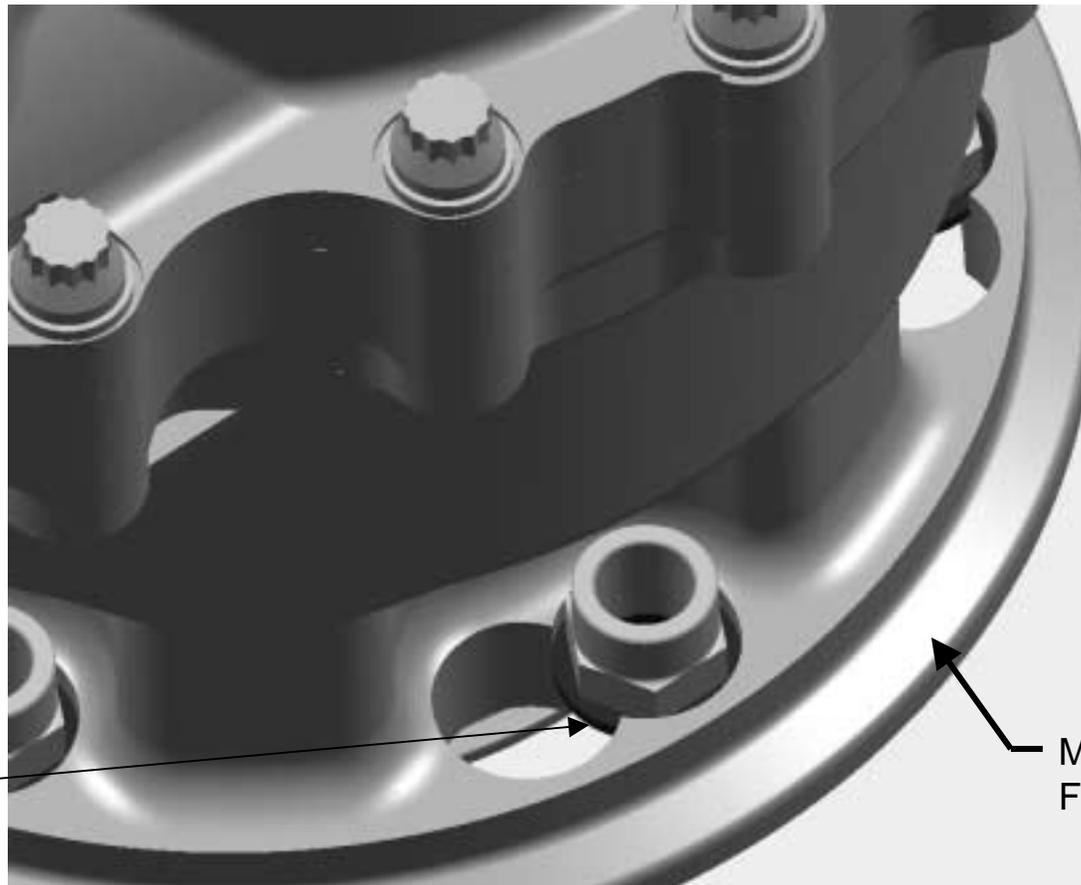
Cupped washer

Washer

Mounting  
Flange

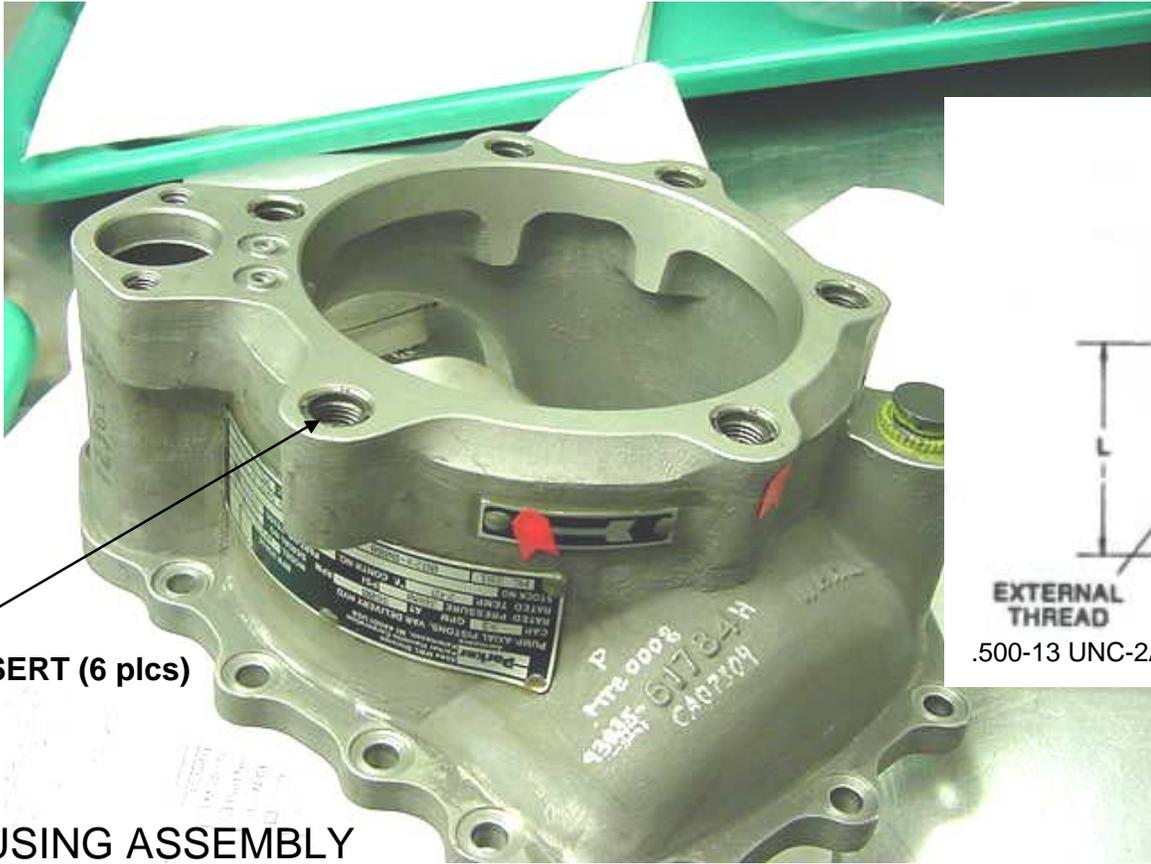
**Port cap / front housing interface utilizes dry film lubricated threaded key locked inserts**

KEY LOCKED INSERT (6 plcs)

FRONT HOUSING ASSEMBLY
