**STS-113**  
**FLIGHT READINESS REVIEW**

**October 31, 2002**

**Ground Operations**

<b>ENGINEERING TOPIC: STS-112 HOLD DOWN POST SYSTEM A PYRO FAILURE</b>	<b>Presenter: John Cipolletti</b>
	<b>Organization/Date: Ground Ops/10-31-02</b>

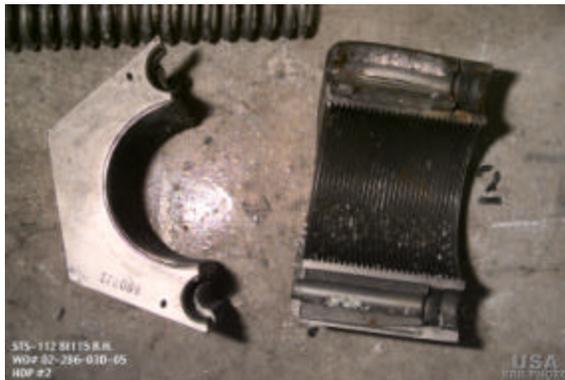
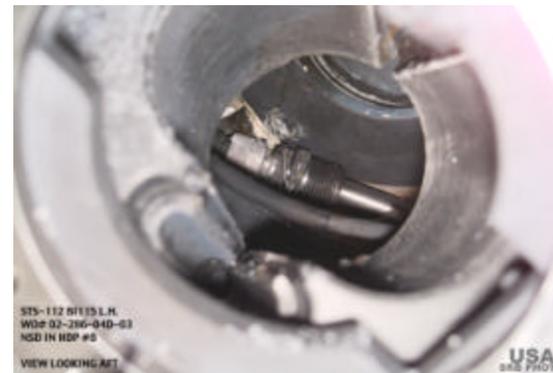
- Possible Causes (From Fault Tree)
  - MEC 1 did not receive the SRB Ignition Command from RSLs
  - MEC 1 failed to send HDP Fire commands to the ground pyro system
  - The Fire 1 command was not transmitted properly from MEC 1 to the PIC Rack Control Panel Assembly (CPA)
  - The ten associated PIC's failed to respond to the MEC 1 command
  - Ten individual PIC outputs to the HDP and ETVAS pyrotechnics were not transmitted properly
  - Ten individual pyrotechnics failed

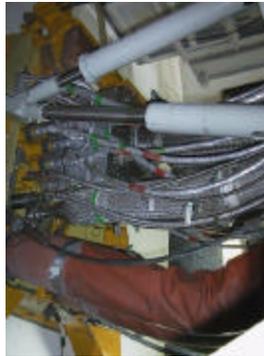
**A) T-0 Umbilical**

**MLP T-0 To HDP Wire Runs**
